Galloper Offshore Wind Farm

Local Notice To Mariners

NTM: GWF-O&M 2021-02

Re: Galloper Windfarm, RWE - NTM: GWF-O&M 2021-02 Defect of the Cable Protection System (CPS) inter-array cable GS-A1L

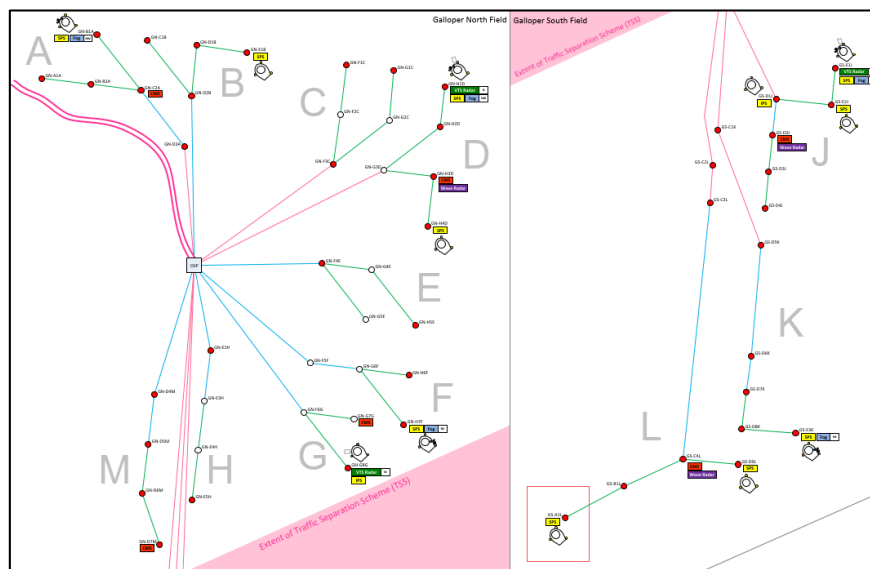
Drawing: A1L CPS damage location

A recent ROV inspection at Galloper to assess the subsea structure of inter-array cable A1L identified a defect of the Cable Protection System (CPS) on top of the existing scour protection around the wind turbine foundation, at the point of burial.

Asset Location	LAT_DM_WGS84	LON_DM_WGS84
GS-A1L	51° 43,972' N	1° 58,174' E

An updated NTM will be issued once the remedial works is confirmed and scheduled

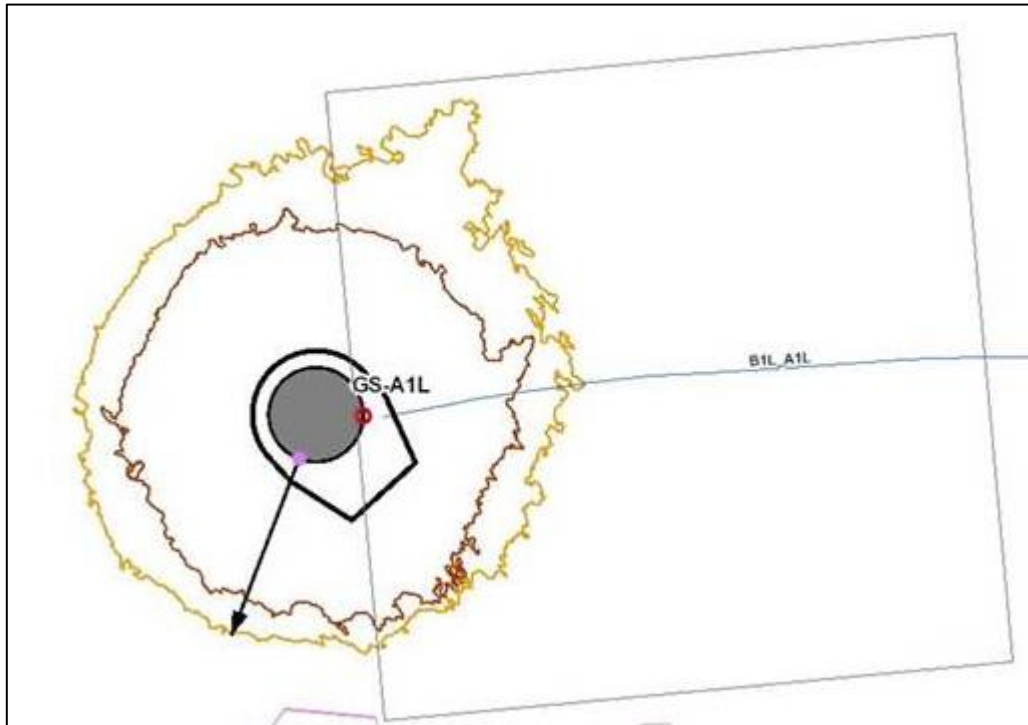
Temporary exclusion area as per the below drawing.

Mariners are requested to remain a distance of 50m away from GS-A1L, 51° 43,972' N 1° 58,174' E, until remedial works have been carried out.
