# NOTICE TO MARINERS

## DOGGER BANK OFFSHORE WIND FARM

DATE OF ISSUE:	11/11/2023
NOTICE TO MARINER NUMBER	LF500013-MIP-DOG-NOT-0026 Rev 0002

### HAZARD - Dogger Bank A OWF Monopiles Unlit

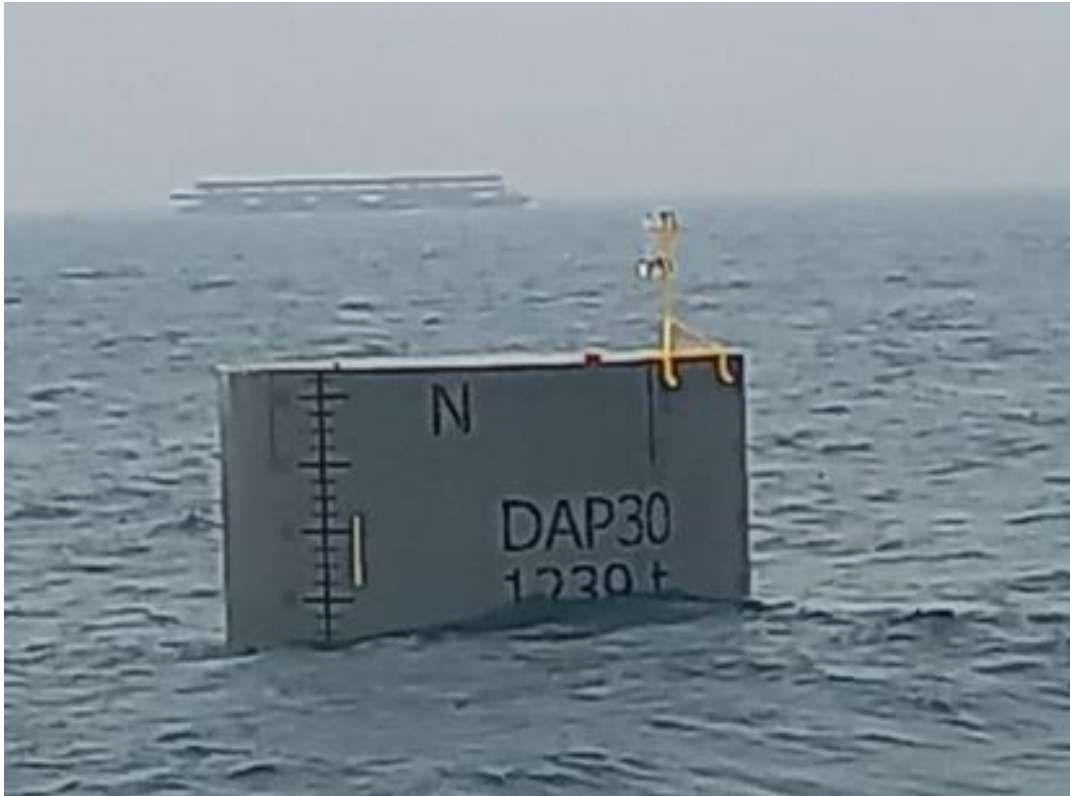
**Figure 3:** Photograph of installed Monopile showing temporary Aid to Navigation Marking

During Storm Babet, the temporary navigation lights on all 38 of the MPs were damaged and the lights are inoperative. Table 2 below provides coordinates of the monopile locations where temporary nav aids are missing or damaged. Figure 3 shows a monopile without a TP installed and with a temporary nav aid in place.

A programme to repair and replace the temporary navigation lights is being undertaken. Once all are restored an update will be published and this NtM will be withdrawn.
