# **Ørsted - East Coast Operational Assets**

## **Notice to Mariners**

**Period of Notice: September 2025**

**Issue: 5**

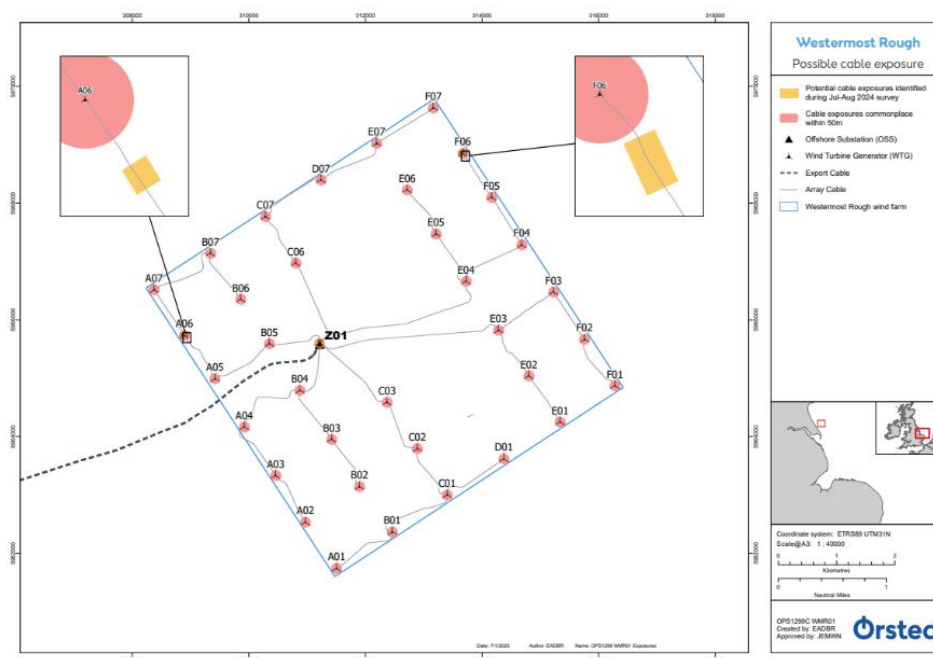
### 6.3 Cable Exposures

As shown in the below chart, a survey undertaken in [July-August 2024] identified potential cable exposures at several locations beyond the commonplace exposures within the 50m radius around wind turbine and offshore substation foundations. The position and extent of the cable exposures shown in the below chart is limited to the burial status observed at the time of the survey. Cable burial status evolves over time, often rapidly. Mariners should not assume otherwise. Cable burial status is monitored periodically, and further information will be provided following future survey campaigns. Ørsted advises mariners to maintain care when operating within windfarm array areas.

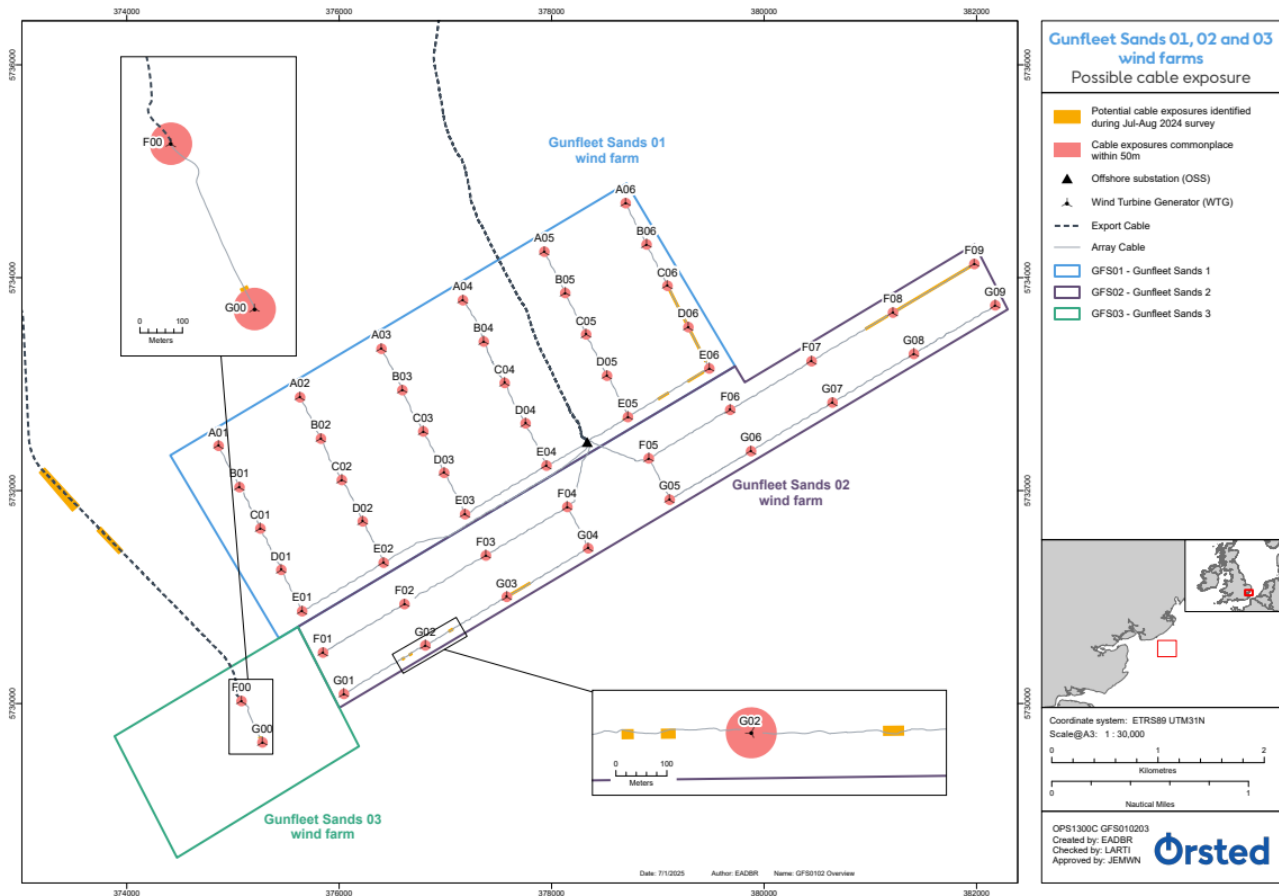
### 8.3 Cable exposure

As shown in the below chart, a survey undertaken in [July-August 2024] identified potential cable exposures at several locations beyond the commonplace exposures within 50m radius around wind turbine and offshore substation foundations. The position and extent of the cable exposures shown in the below chart is limited to the burial status observed at the time of the survey. Cable burial status evolves over time, often rapidly. Mariners should not assume otherwise. Cable burial status is monitored periodically, and further information will be provided following future survey campaigns. Ørsted advises mariners to maintain care when operating within our windfarm array areas.

As a result of a sedimentary surface and above average flow velocities, bathymetry within the Gunfleet Sands array area is constantly evolving.
