# **Ørsted - East Coast Operational Assets**

## **Notice to Mariners**

**Period of Notice: October 2025**

**Issue: 2**

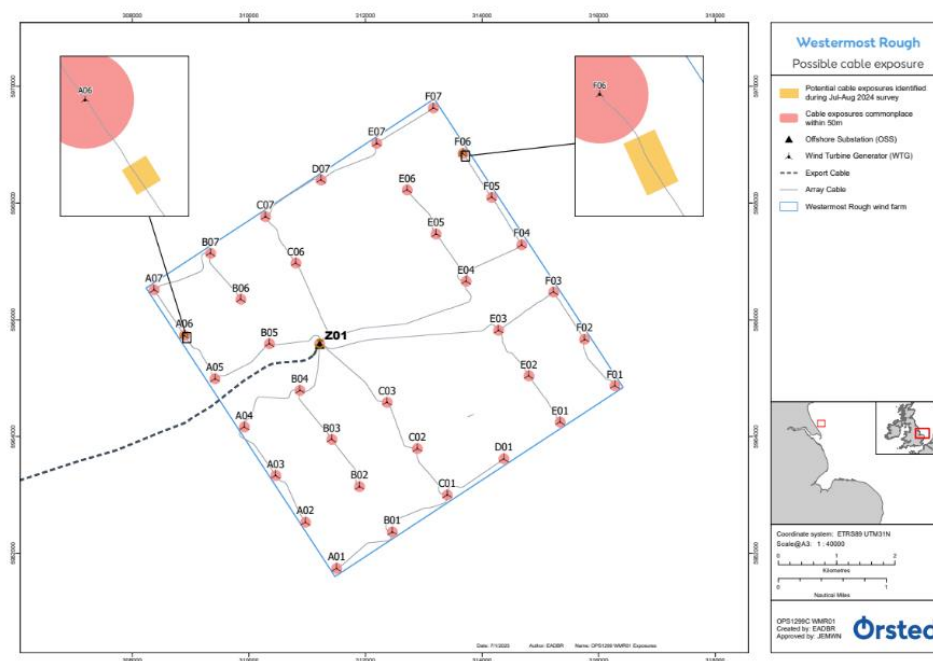
### 6.3 Cable Exposures

As shown in the below chart, a survey undertaken in [July-August 2024] identified potential cable exposures at several locations beyond the commonplace exposures within the 50m radius around wind turbine and offshore substation foundations. The position and extent of the cable exposures shown in the below chart is limited to the burial status observed at the time of the survey. Cable burial status evolves over time, often rapidly. Mariners should not assume otherwise. Cable burial status is monitored periodically, and further information will be provided following future survey campaigns. Ørsted advises mariners to maintain care when operating within windfarm array areas.
