# **Ørsted - East Coast Operational Assets**

## **Notice to Mariners**

**Period of Notice: November 2025**

**Issue: 2**

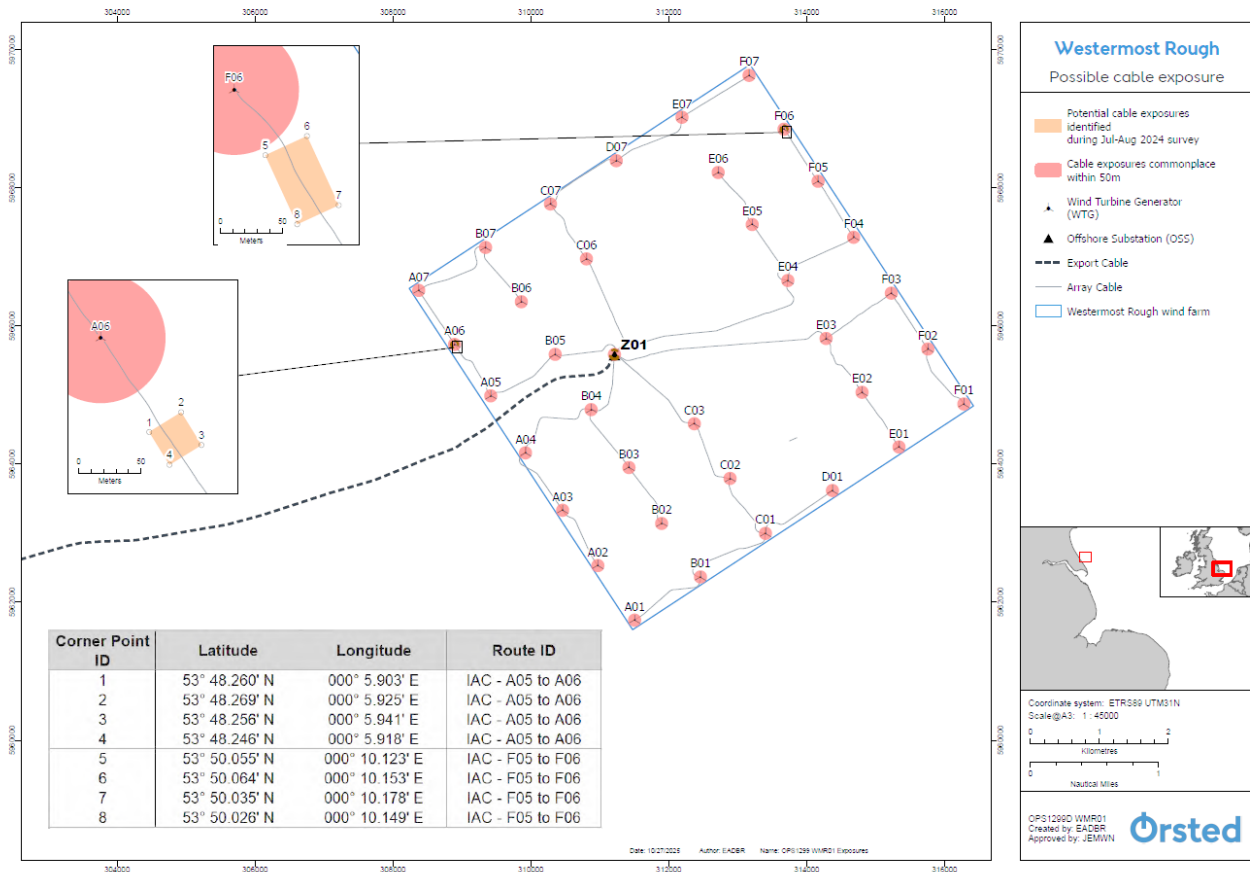
As shown in the below chart, a survey undertaken in [July-August 2024] identified potential cable exposures at several locations beyond the commonplace exposures within the 50m radius around wind turbine and offshore substation foundations. The position and extent of the cable exposures shown in the below chart is limited to the burial status observed at the time of the survey. Cable burial status evolves over time, often rapidly. Mariners should not assume otherwise. Cable burial status is monitored periodically, and further information will be provided following future survey campaigns. Ørsted advises mariners to maintain care when operating within windfarm array areas.

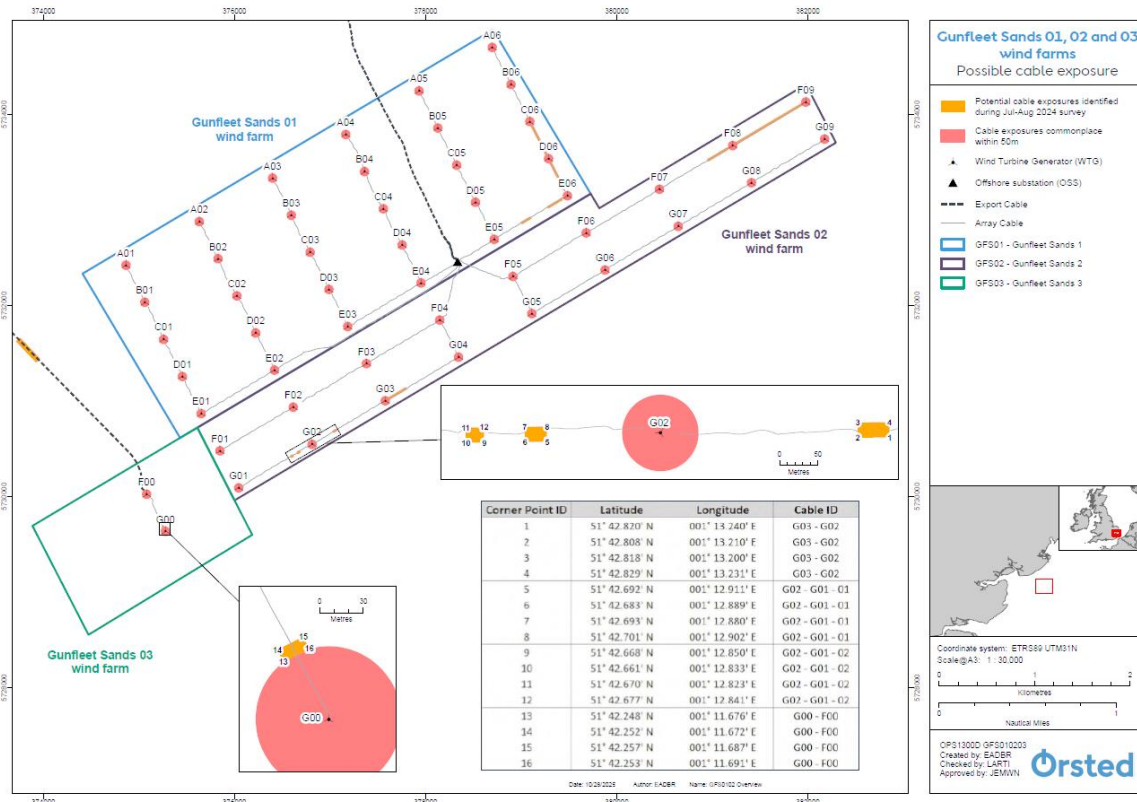
As shown in the below chart, a survey undertaken in [July-August 2024] identified potential cable exposures at several locations beyond the commonplace exposures within 50m radius around wind turbine and offshore substation foundations. The position and extent of the cable exposures shown in the below chart is limited to the burial status observed at the time of the survey. Cable burial status evolves over time, often rapidly. Mariners should not assume otherwise. Cable burial status is monitored periodically, and further information will be provided following future survey campaigns. Orsted advises mariners to maintain care when operating within our windfarm array areas.

As a result of a sedimentary surface and above average flow velocities, bathymetry within the Gunfleet Sands array area is constantly evolving.
