Ørsted - East Coast Operational Assets

Notice to Mariners

Period of Notice: November 2025

Issue: 4

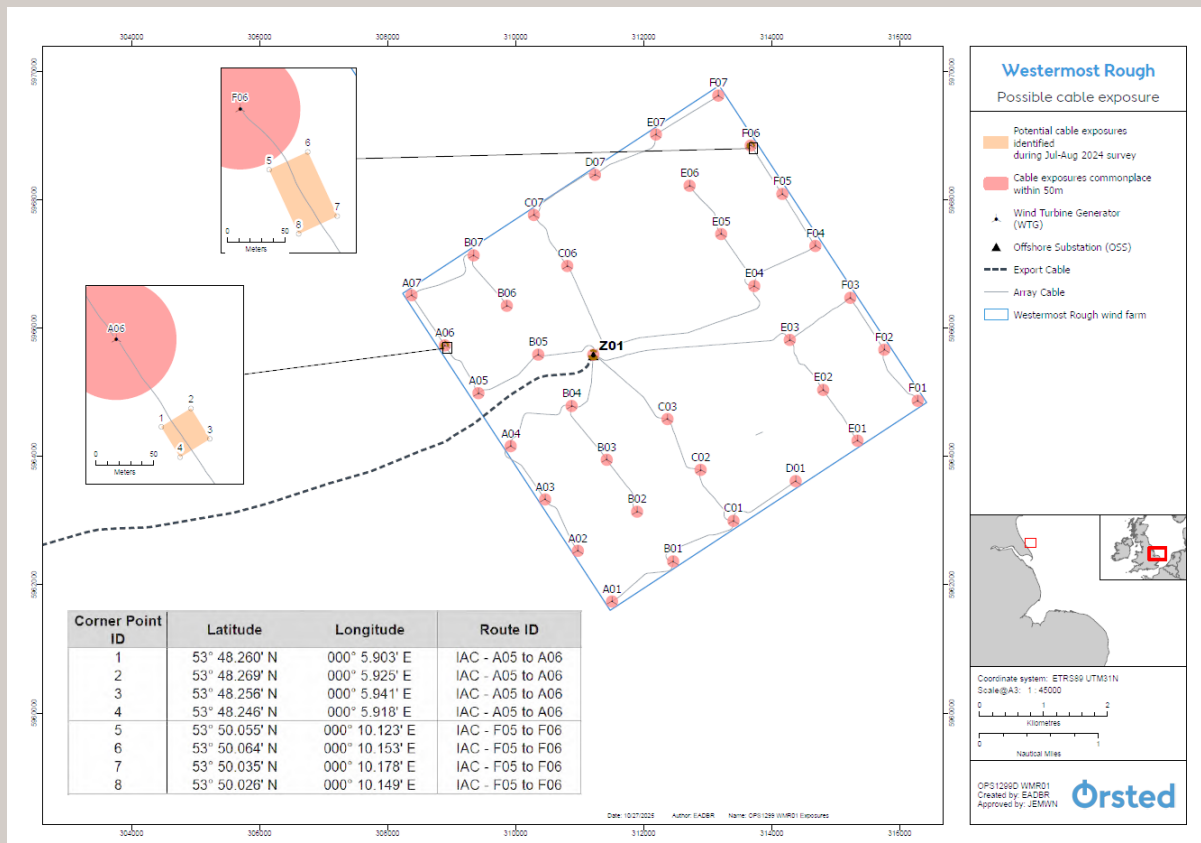
6.1 Cable Exposures

As shown in the below chart, a survey undertaken in [July-August 2024] identified potential cable exposures at several locations beyond the commonplace exposures within the 50m radius around wind turbine and offshore substation foundations. The position and extent of the cable exposures shown in the below chart is limited to the burial status observed at the time of the survey. Cable burial status evolves over time, often rapidly. Mariners should not assume otherwise. Cable burial status is monitored periodically, and further information will be provided following future survey campaigns. Ørsted advises mariners to maintain care when operating within windfarm array areas.

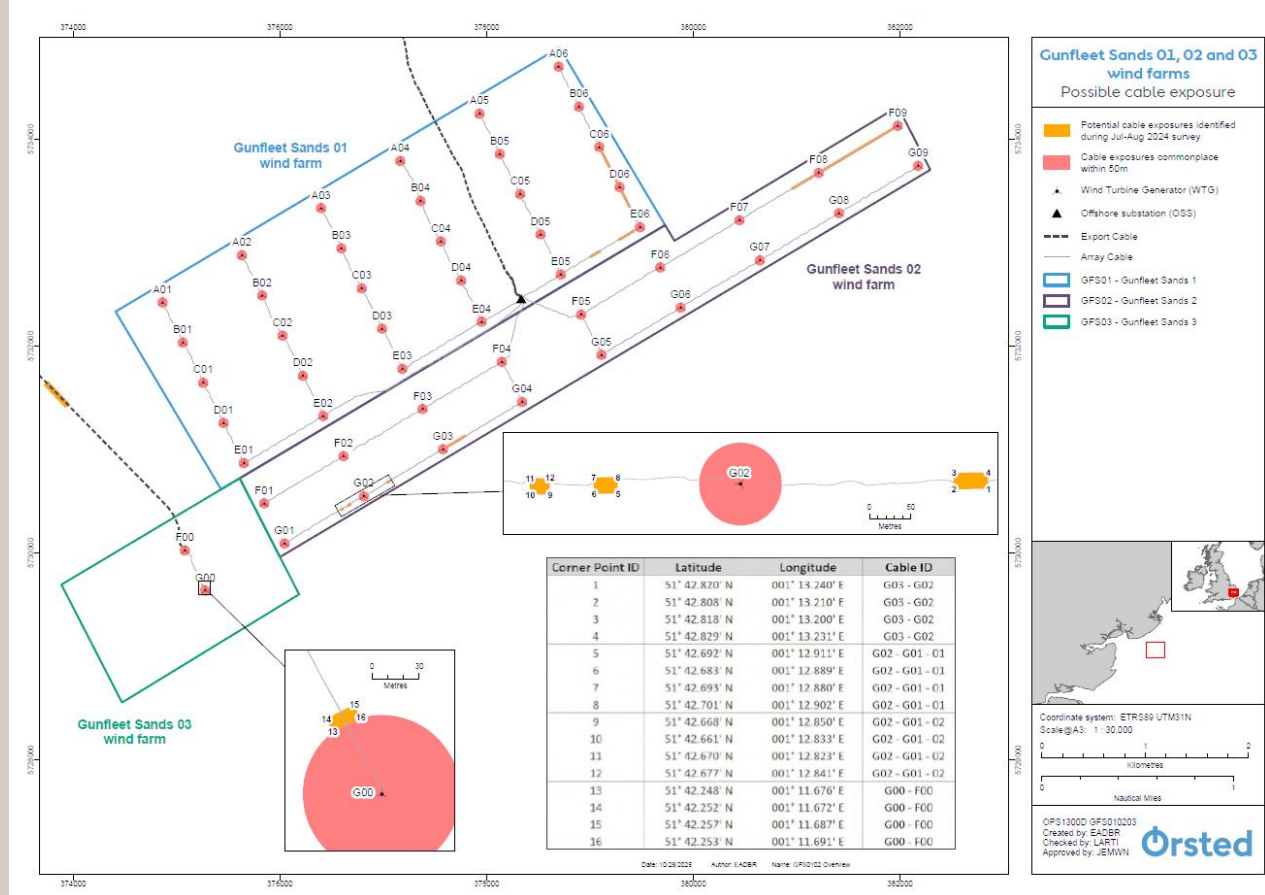
As shown in the below chart, a survey undertaken in [July-August 2024] identified potential cable exposures at several locations beyond the commonplace exposures within 50m radius around wind turbine and offshore substation foundations. The position and extent of the cable exposures shown in the below chart is limited to the burial status observed at the time of the survey. Cable burial status evolves over time, often rapidly. Mariners should not assume otherwise. Cable burial status is monitored periodically, and further information will be provided following future survey campaigns. Orsted advises mariners to maintain care when operating within our windfarm array areas.

As a result of a sedimentary surface and above average flow velocities, bathymetry within the Gunfleet Sands array area is constantly evolving.
