# **Ørsted - East Coast Operational Assets**

## **Notice to Mariners**

**Period of Notice: November 2025**

**Issue: 5**

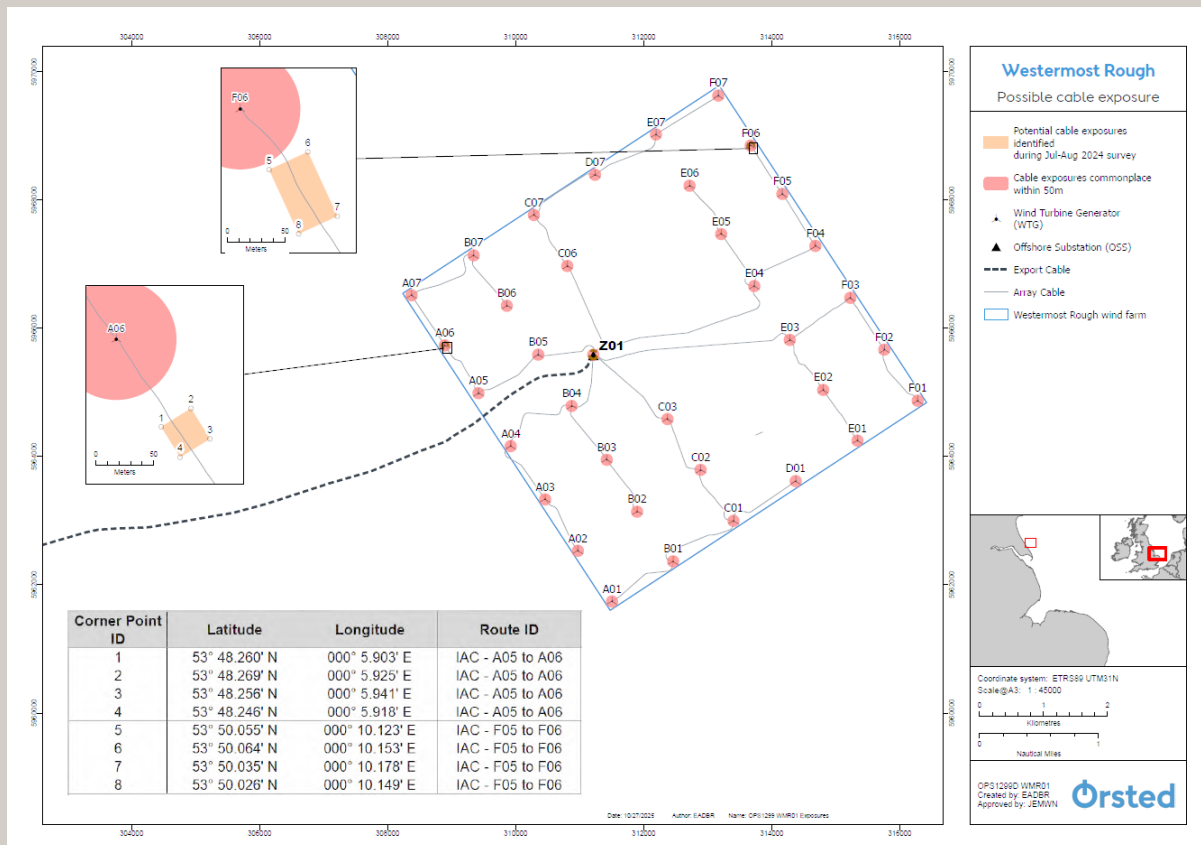
## 6.1 Cable Exposures

As shown in the below chart, a survey undertaken in [July-August 2024] identified potential cable exposures at several locations beyond the commonplace exposures within the 50m radius around wind turbine and offshore substation foundations. The position and extent of the cable exposures shown in the below chart is limited to the burial status observed at the time of the survey. Cable burial status evolves over time, often rapidly. Mariners should not assume otherwise. Cable burial status is monitored periodically, and further information will be provided following future survey campaigns. Ørsted advises mariners to maintain care when operating within windfarm array areas.

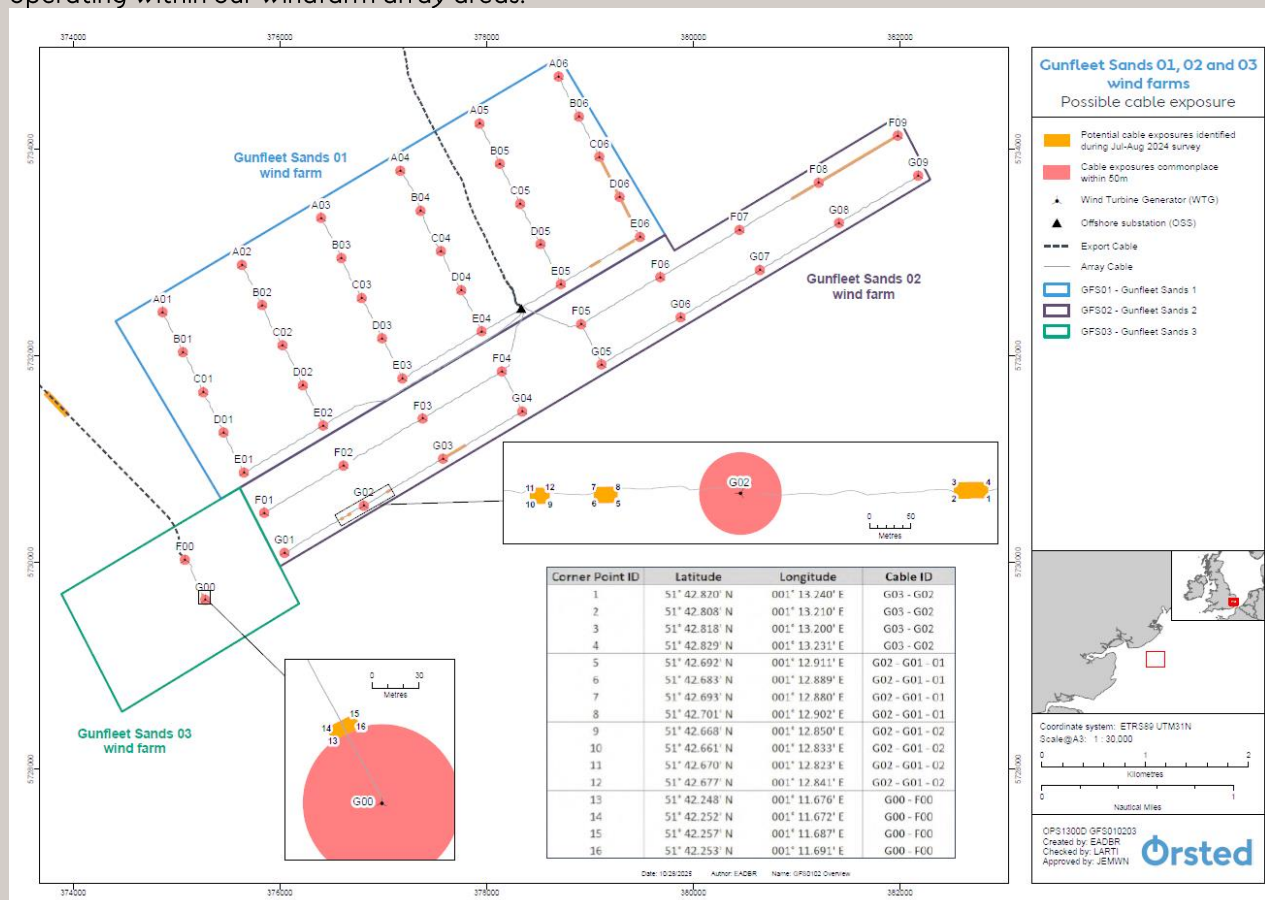
### 8.3 Cable exposure

As shown in the below chart, a survey undertaken in [July-August 2024] identified potential cable exposures at several locations beyond the commonplace exposures within 50m radius around wind turbine and offshore substation foundations. The position and extent of the cable exposures shown in the below chart is limited to the burial status observed at the time of the survey. Cable burial status evolves over time, often rapidly. Mariners should not assume otherwise. Cable burial status is monitored periodically, and further information will be provided following future survey campaigns. Orsted advises mariners to maintain care when operating within our windfarm array areas.

As a result of a sedimentary surface and above average flow velocities, bathymetry within the Gunfleet Sands array area is constantly evolving.
