Ørsted - East Coast Operational Assets

Notice to Mariners

Period of Notice: January 2026

Issue: 2

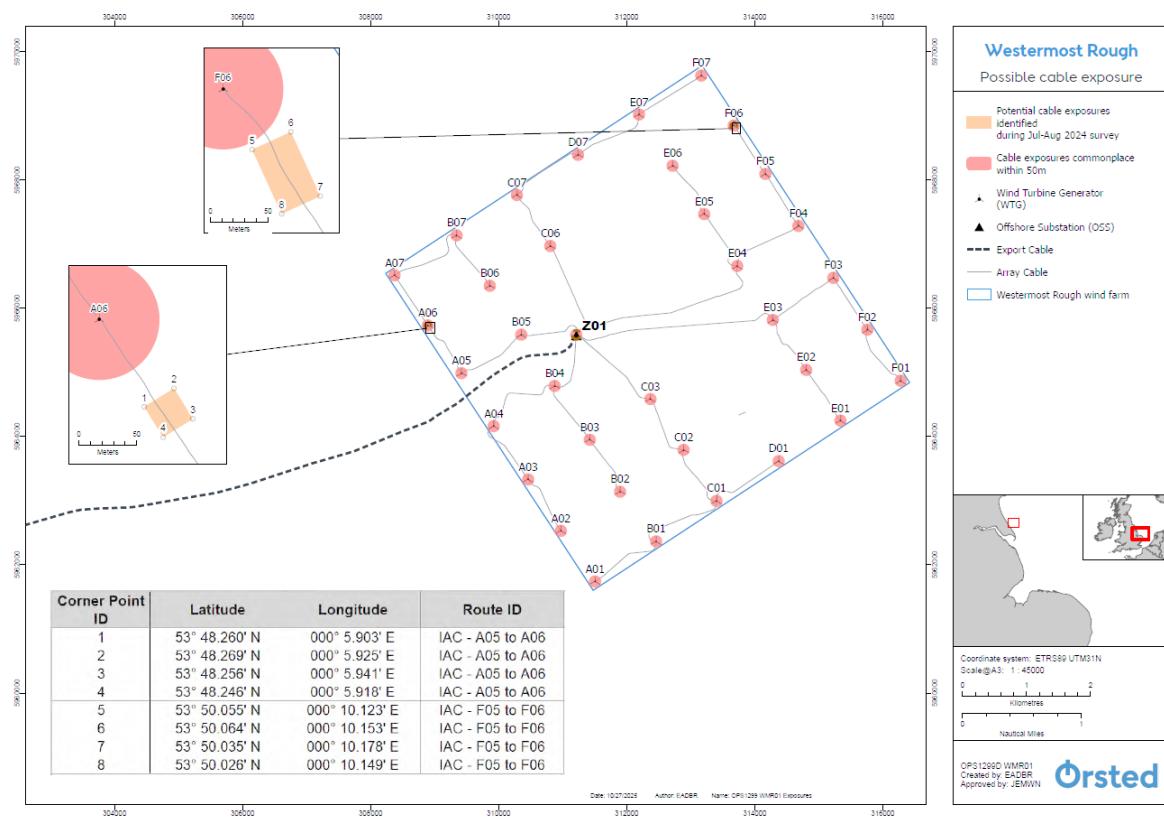
6.3 Cable Exposures

As shown in the below chart, a survey undertaken in [July-August 2024] identified potential cable exposures at several locations beyond the commonplace exposures within the 50m radius around wind turbine and offshore substation foundations. The position and extent of the cable exposures shown in the below chart is limited to the burial status observed at the time of the survey. Cable burial status evolves over time, often rapidly. Mariners should not assume otherwise. Cable burial status is monitored periodically, and further information will be provided following future survey campaigns. Ørsted advises mariners to maintain care when operating within windfarm array areas.

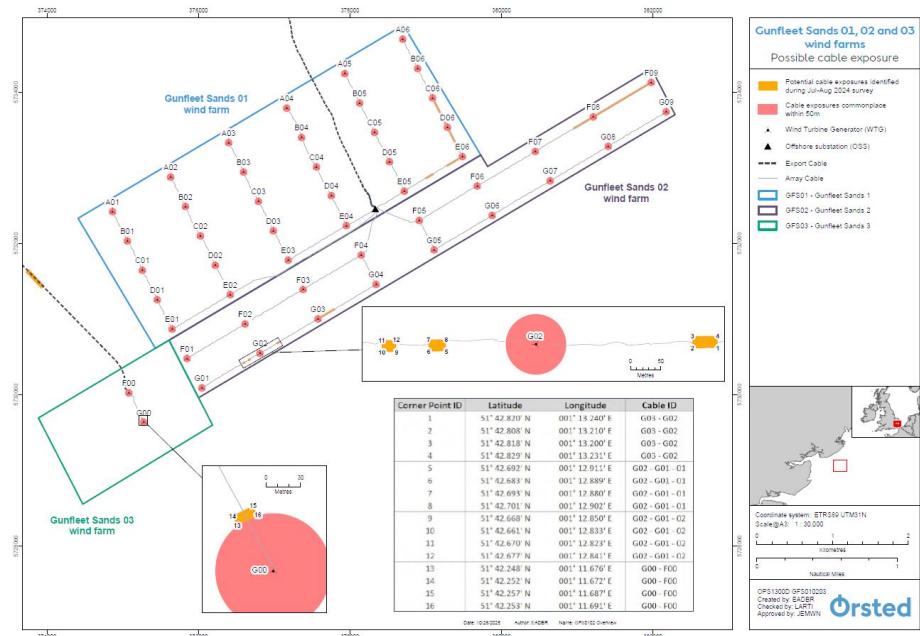
8.3 Cable exposure

As shown in the below chart, a survey undertaken in [July-August 2024] identified potential cable exposures at several locations beyond the commonplace exposures within 50m radius around wind turbine and offshore substation foundations. The position and extent of the cable exposures shown in the below chart is limited to the burial status observed at the time of the survey. Cable burial status evolves over time, often rapidly. Mariners should not assume otherwise. Cable burial status is monitored periodically, and further information will be provided following future survey campaigns. Ørsted advises mariners to maintain care when operating within our windfarm array areas.

As a result of a sedimentary surface and above average flow velocities, bathymetry within the Gunfleet Sands array area is constantly evolving.
