# **Ørsted - East Coast Operational Assets**

## **Notice to Mariners**

**Period of Notice: February 2026**

**Issue: 1**

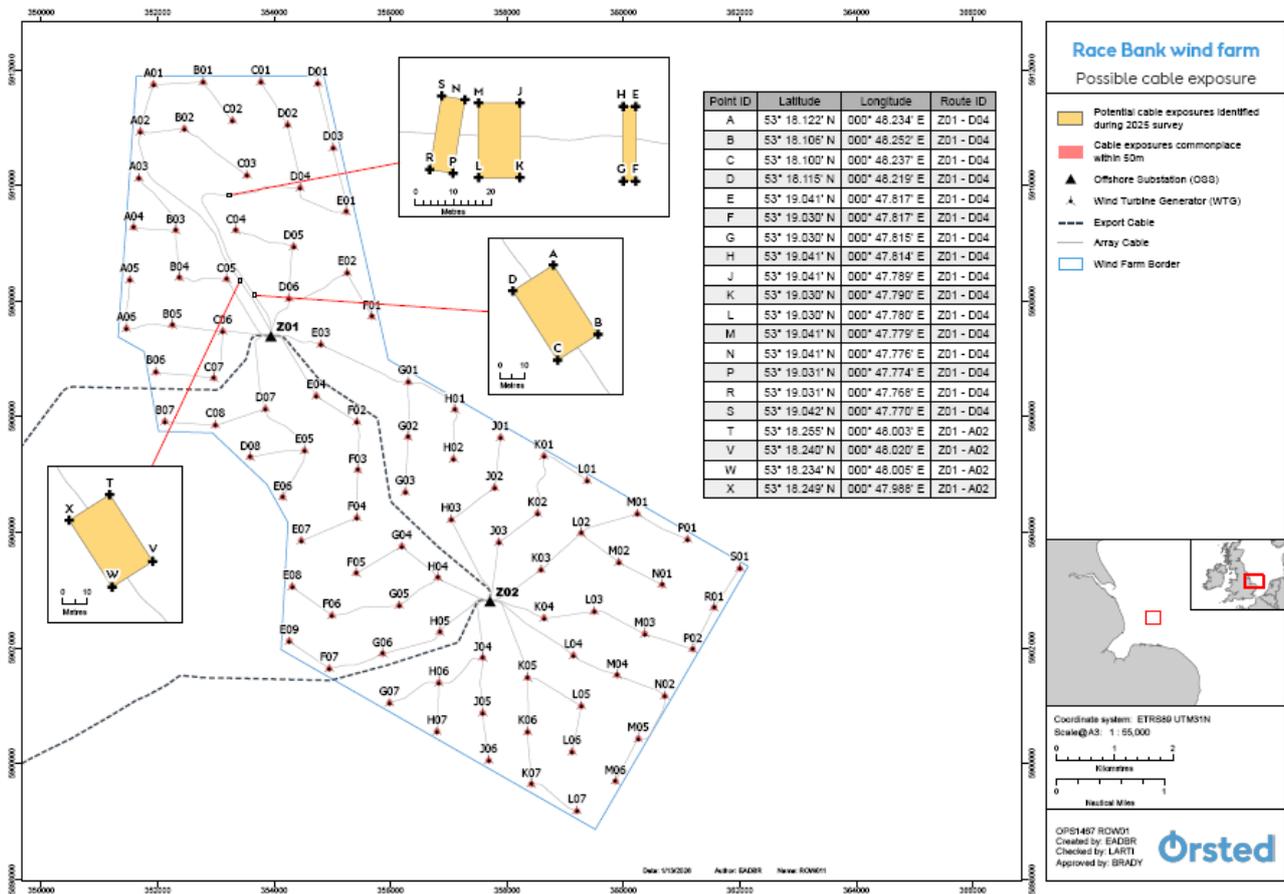
### 5.3 Cable exposure

As shown in the below chart, a survey undertaken in [July 2025] identified potential cable exposures at several locations beyond the commonplace exposures within the 50m radius around wind turbine and offshore substation foundations. The position and extent of the cable exposures shown in the below chart is limited to the burial status observed at the time of the survey. Cable burial status evolves over time, often rapidly. Mariners should not assume otherwise. Cable burial status is monitored periodically, and further information will be provided following future survey campaigns. Ørsted advises mariners to maintain care when operating within windfarm array areas.

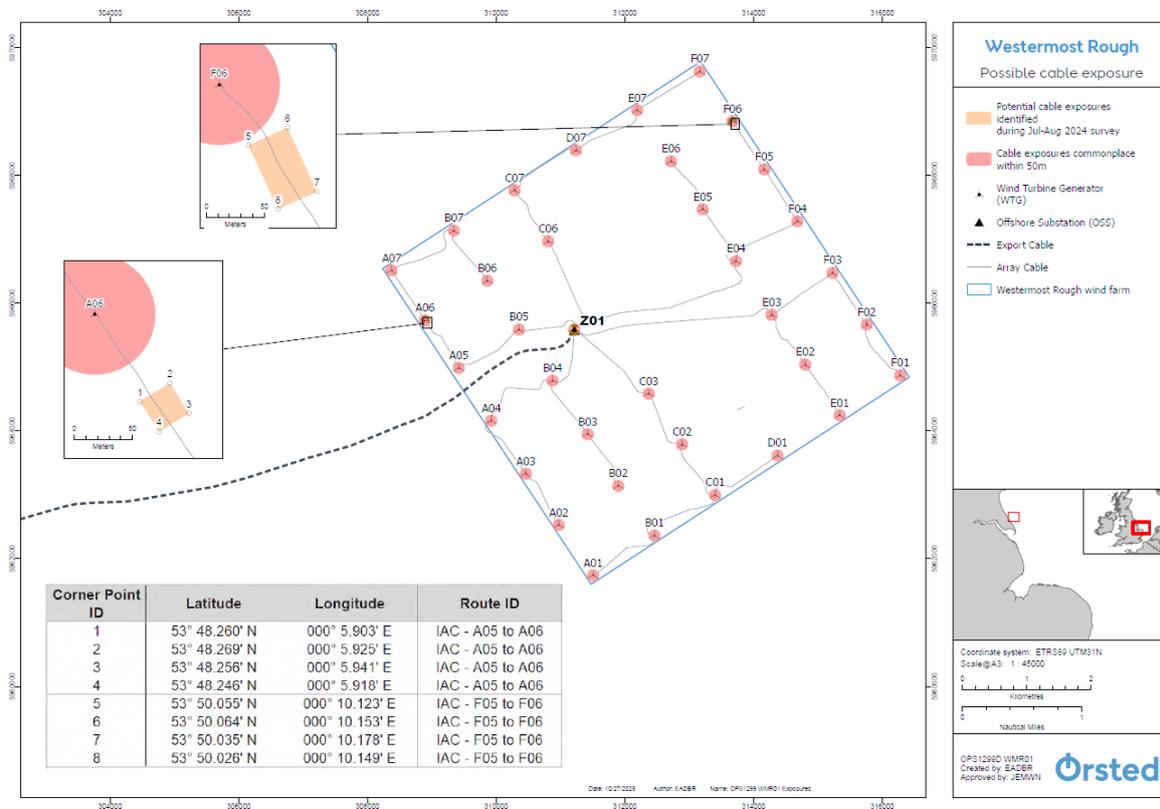
### 6.3 Cable Exposures

As shown in the below chart, a survey undertaken in [July-August 2024] identified potential cable exposures at several locations beyond the commonplace exposures within the 50m radius around wind turbine and offshore substation foundations. The position and extent of the cable exposures shown in the below chart is limited to the burial status observed at the time of the survey. Cable burial status evolves over time, often rapidly. Mariners should not assume otherwise. Cable burial status is monitored periodically, and further information will be provided following future survey campaigns. Ørsted advises mariners to maintain care when operating within windfarm array areas.

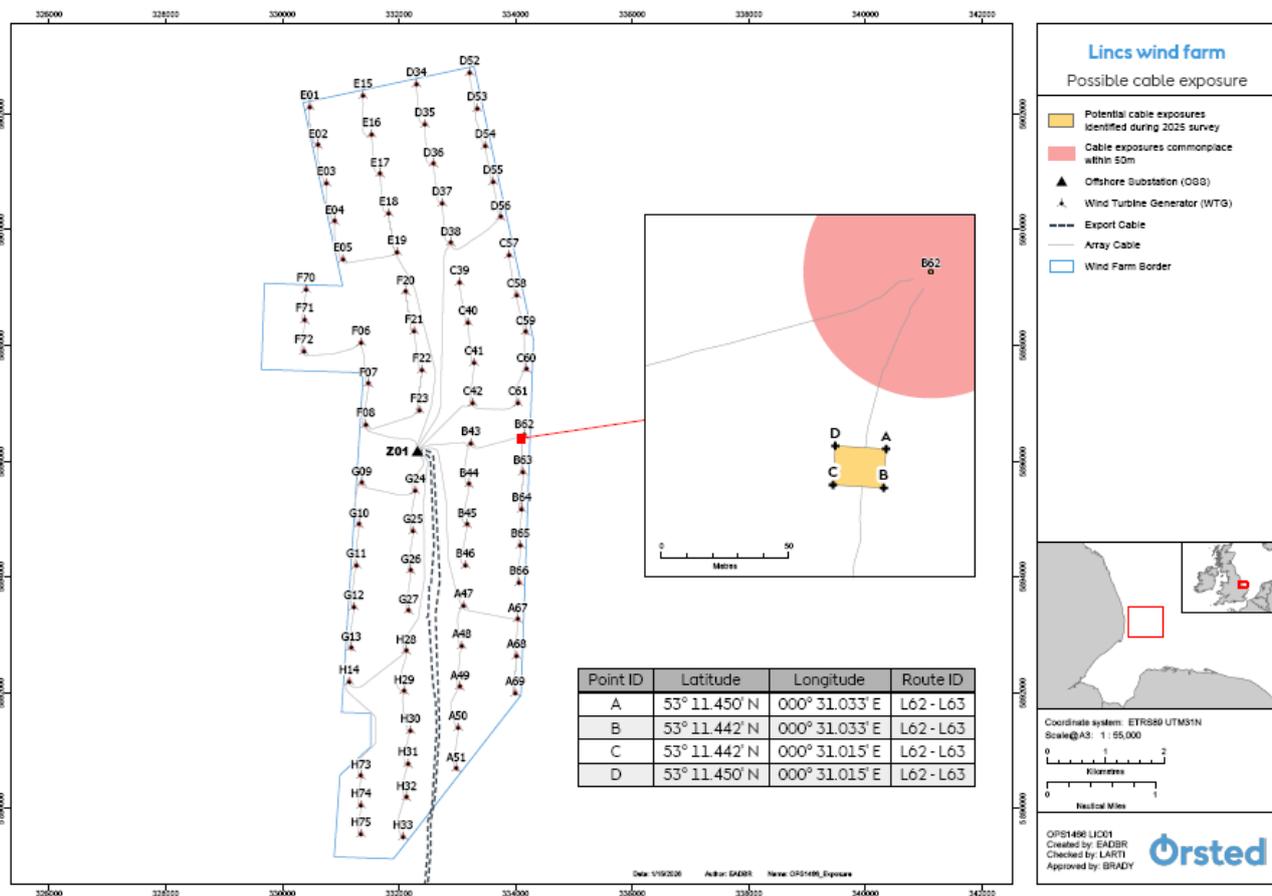
### 7.3 Cable exposure

As shown in the below chart, a survey undertaken in [July 2025] identified potential cable exposures at several locations beyond the commonplace exposures within the 50m radius around wind turbine and offshore substation foundations. The position and extent of the cable exposures shown in the below chart is limited to the burial status observed at the time of the survey. Cable burial status evolves over time, often rapidly. Mariners should not assume otherwise. Cable burial status is monitored periodically, and further information will be provided following future survey campaigns. Ørsted advises mariners to maintain care when operating within wind farm array areas.

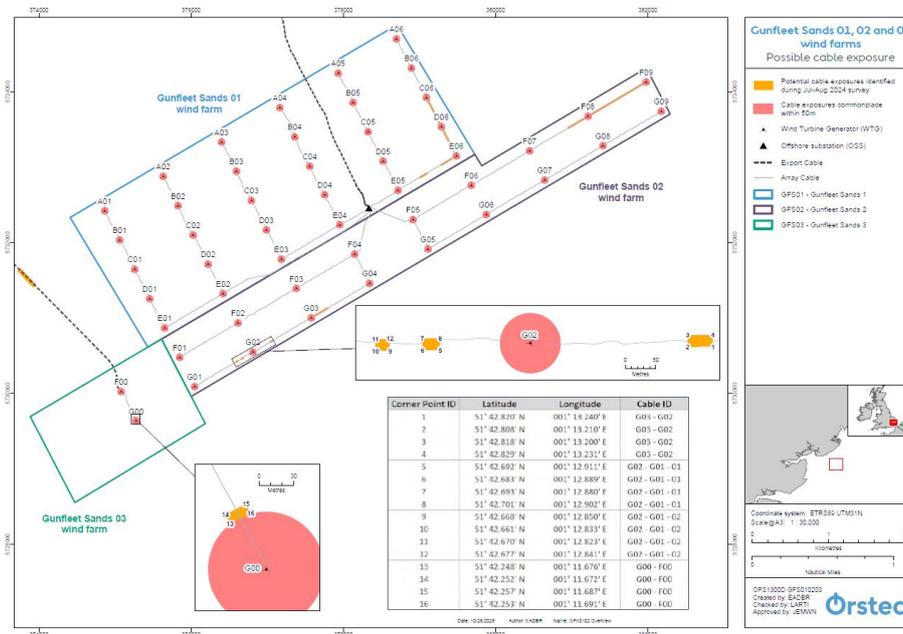
### 8.3 Cable Exposure

As shown in the below chart, a survey undertaken in [July-August 2024] identified potential cable exposures at several locations beyond the commonplace exposures within 50m radius around wind turbine and offshore substation foundations. The position and extent of the cable exposures shown in the below chart is limited to the burial status observed at the time of the survey. Cable burial status evolves over time, often rapidly. Mariners should not assume otherwise. Cable burial status is monitored periodically, and further information will be provided following future survey campaigns. Orsted advises mariners to maintain care when operating within our windfarm array areas.

As a result of a sedimentary surface and above average flow velocities, bathymetry within the Gunfleet Sands array area is constantly evolving.
