Ørsted - East Coast Operational Assets

Notice to Mariners

Period of Notice: February 2026

Issue: 3

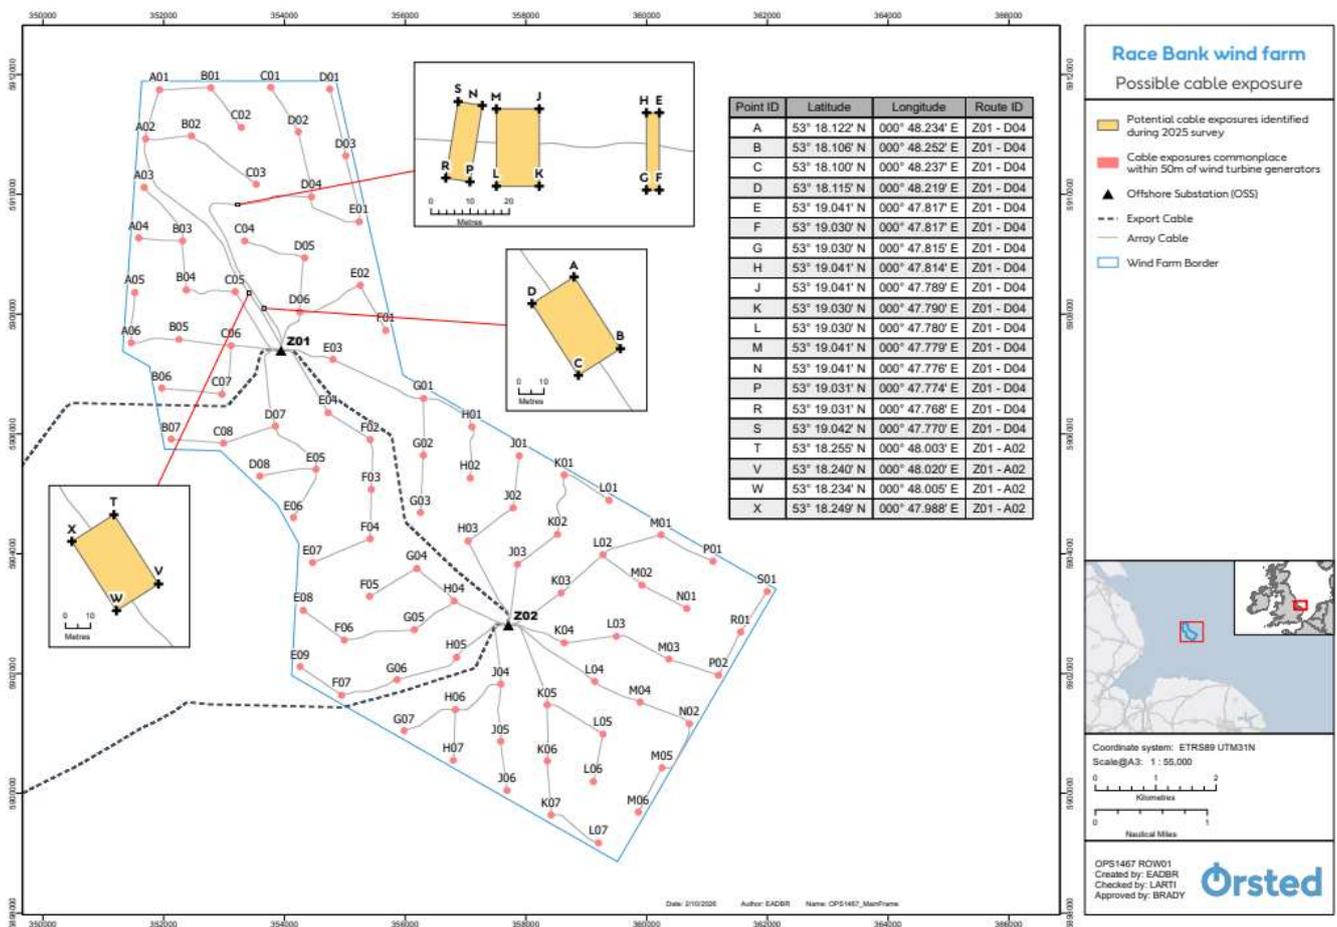
As shown in the below chart, a survey undertaken in [July 2025] identified potential cable exposures at locations beyond the commonplace exposures within the 50m radius around wind turbine and offshore substation foundations. The position and extent of the cable exposures shown in the below chart is limited to the burial status observed at the time of the survey. Cable burial status evolves over time, often rapidly. Mariners should not assume otherwise. Cable burial status is monitored periodically, and further information will be provided following future survey campaigns. Ørsted advises mariners to maintain care when operating within windfarm array areas.

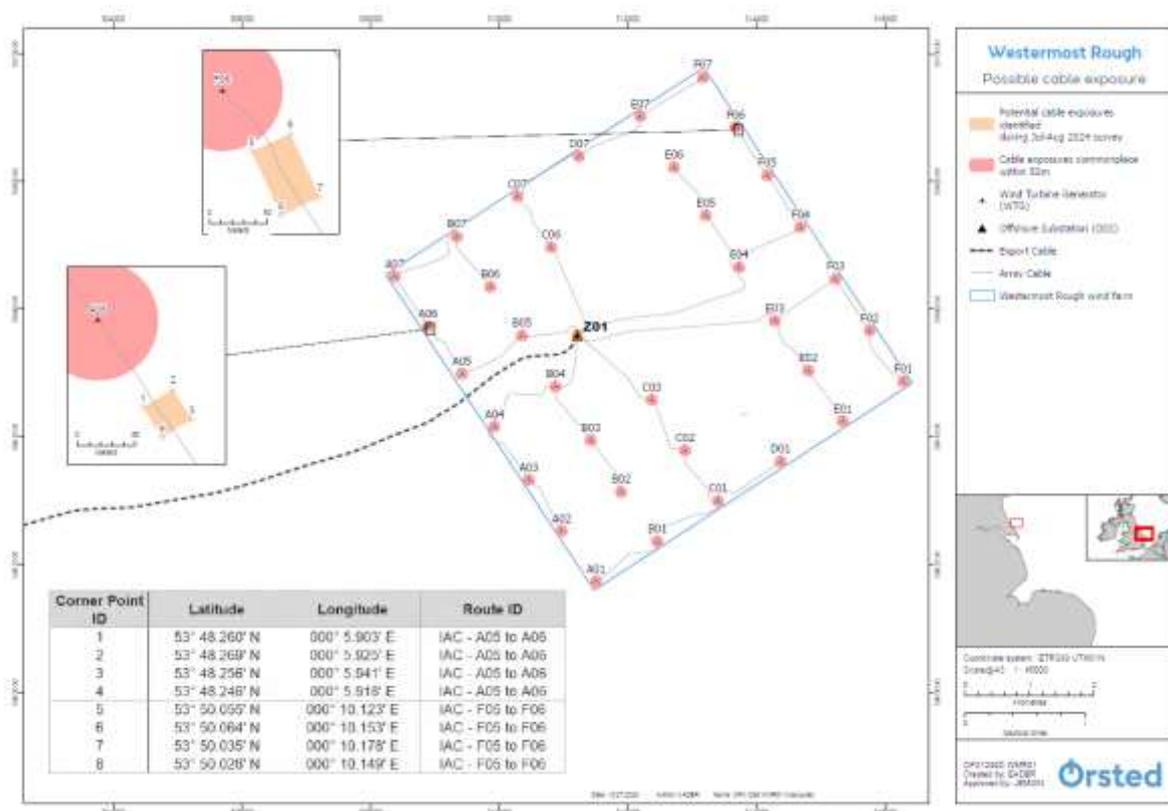
As shown in the below chart, a survey undertaken in [July-August 2024] identified potential cable exposures at locations beyond the commonplace exposures within the 50m radius around wind turbine and offshore substation foundations. The position and extent of the cable exposures shown in the below chart is limited to the burial status observed at the time of the survey. Cable burial status evolves over time, often rapidly. Mariners should not assume otherwise. Cable burial status is monitored periodically, and further information will be provided following future survey campaigns. Ørsted advises mariners to maintain care when operating within windfarm array areas.

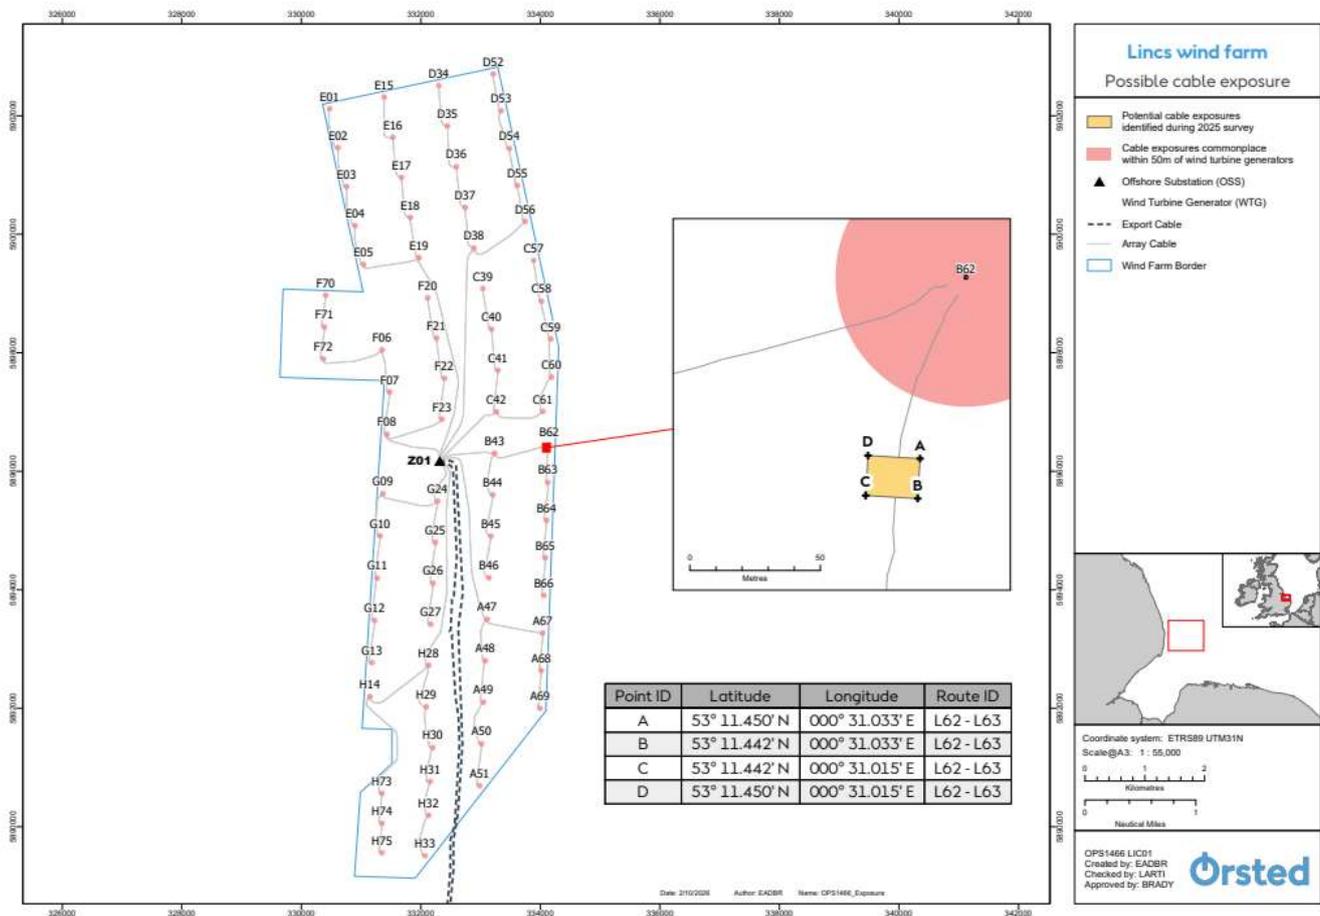
As shown in the below chart, a survey undertaken in [July 2025] identified potential cable exposures at locations beyond the commonplace exposures within the 50m radius around wind turbine and offshore substation foundations. The position and extent of the cable exposures shown in the below chart is limited to the burial status observed at the time of the survey. Cable burial status evolves over time, often rapidly. Mariners should not assume otherwise. Cable burial status is monitored periodically, and further information will be provided following future survey campaigns. Ørsted advises mariners to maintain care when operating within windfarm array areas.

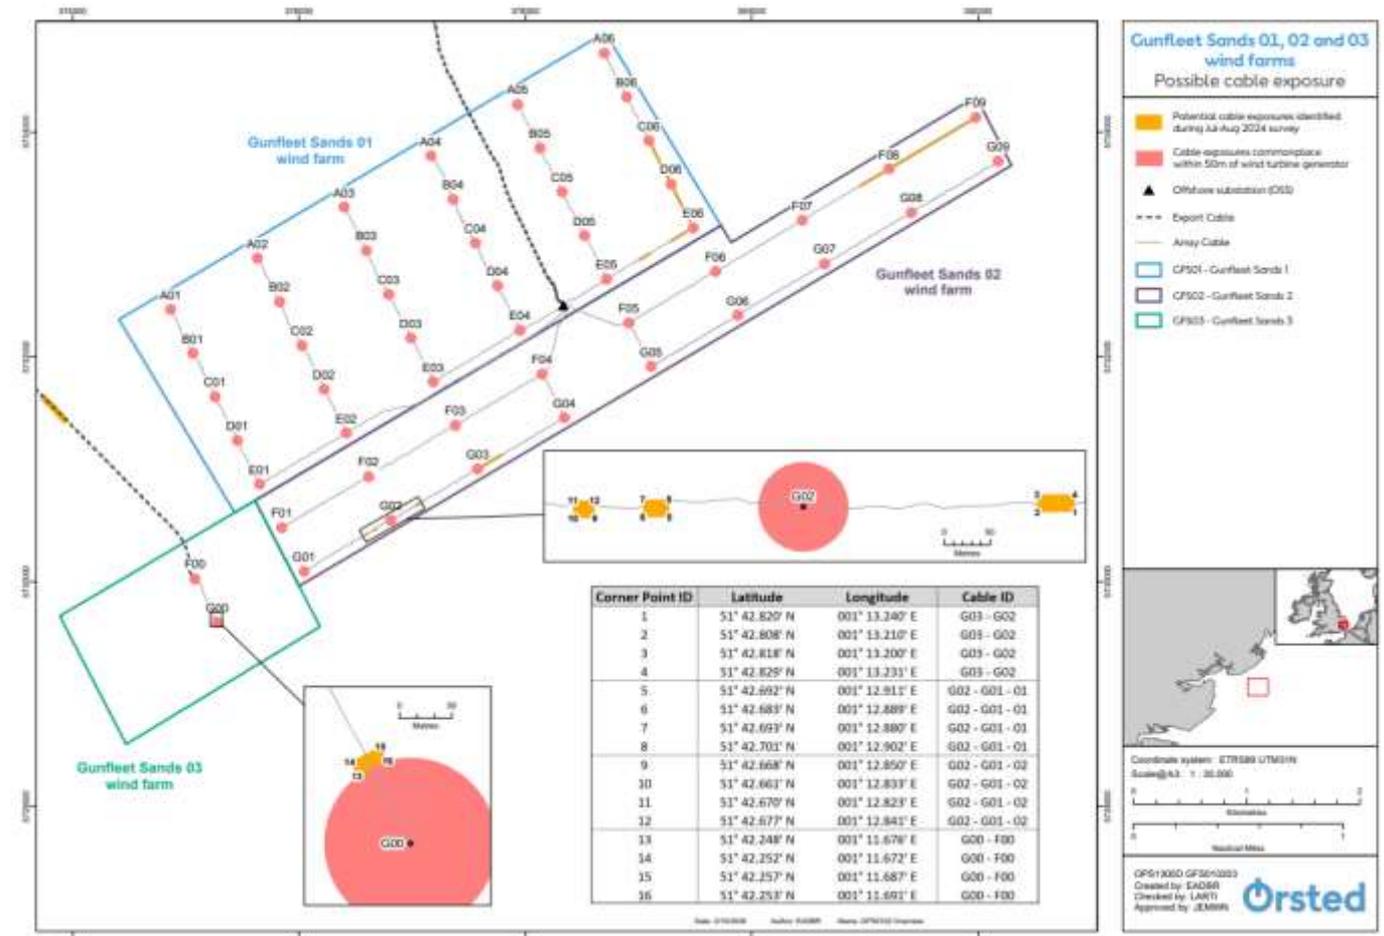
As shown in the below chart, a survey undertaken in [July-August 2024] identified potential cable exposures at locations beyond the commonplace exposures within 50m radius around wind turbine and offshore substation foundations. The position and extent of the cable exposures shown in the below chart is limited to the burial status observed at the time of the survey. Cable burial status evolves over time, often rapidly. Mariners should not assume otherwise. Cable burial status is monitored periodically, and further information will be provided following future survey campaigns. Orsted advises mariners to maintain care when operating within our windfarm array areas.

As a result of a sedimentary surface and above average flow velocities, bathymetry within the Gunfleet Sands array area is constantly evolving.
