Ørsted - East Coast Operational Assets

Notice to Mariners

Period of Notice: January 2026

Issue: 4

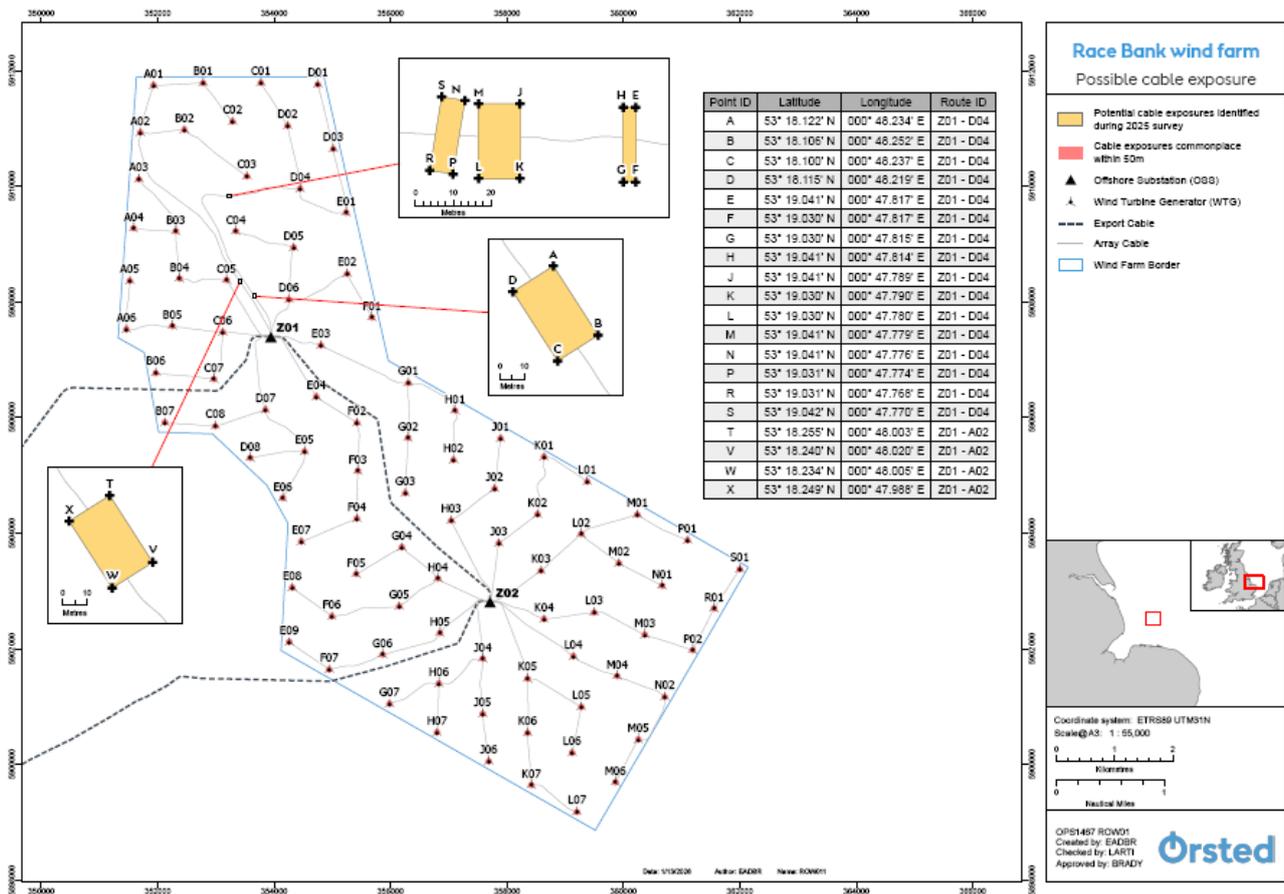
5.3 Cable exposure

As shown in the below chart, a survey undertaken in [July 2025] identified potential cable exposures at several locations beyond the commonplace exposures within the 50m radius around wind turbine and offshore substation foundations. The position and extent of the cable exposures shown in the below chart is limited to the burial status observed at the time of the survey. Cable burial status evolves over time, often rapidly. Mariners should not assume otherwise. Cable burial status is monitored periodically, and further information will be provided following future survey campaigns. Ørsted advises mariners to maintain care when operating within windfarm array areas.

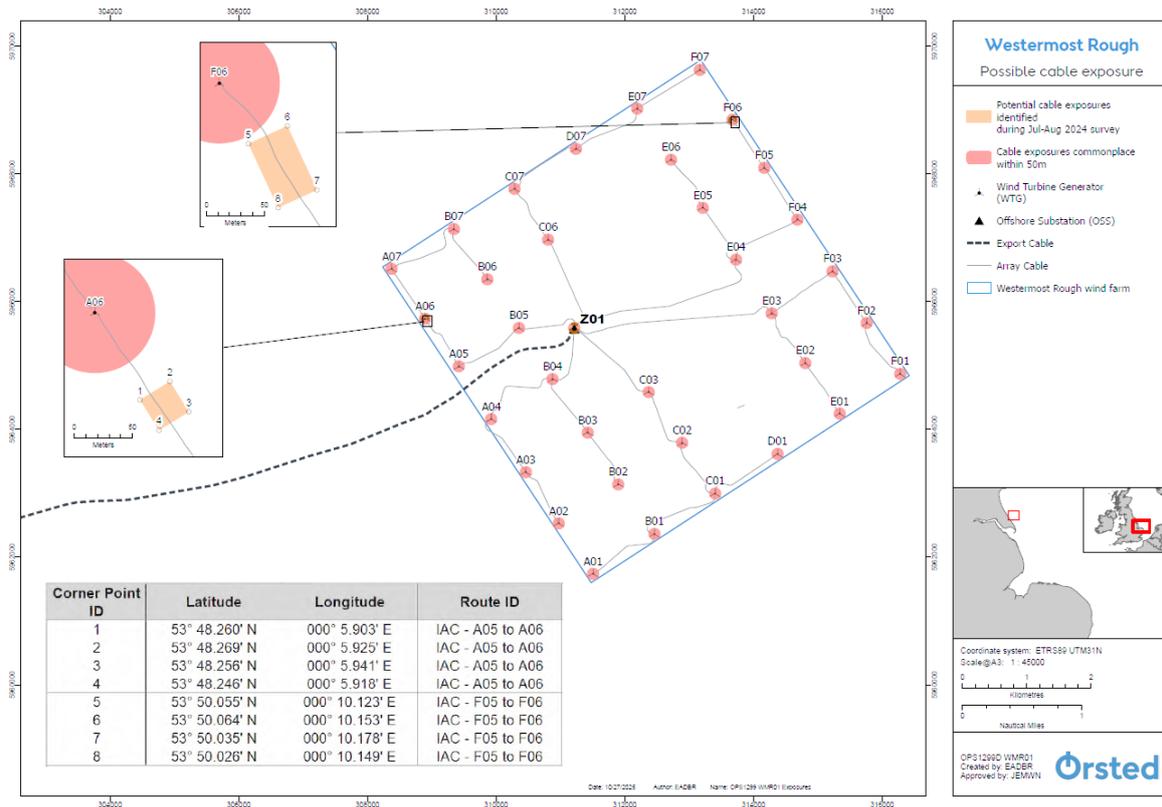
6.3 Cable Exposures

As shown in the below chart, a survey undertaken in [July-August 2024] identified potential cable exposures at several locations beyond the commonplace exposures within the 50m radius around wind turbine and offshore substation foundations. The position and extent of the cable exposures shown in the below chart is limited to the burial status observed at the time of the survey. Cable burial status evolves over time, often rapidly. Mariners should not assume otherwise. Cable burial status is monitored periodically, and further information will be provided following future survey campaigns. Ørsted advises mariners to maintain care when operating within windfarm array areas.

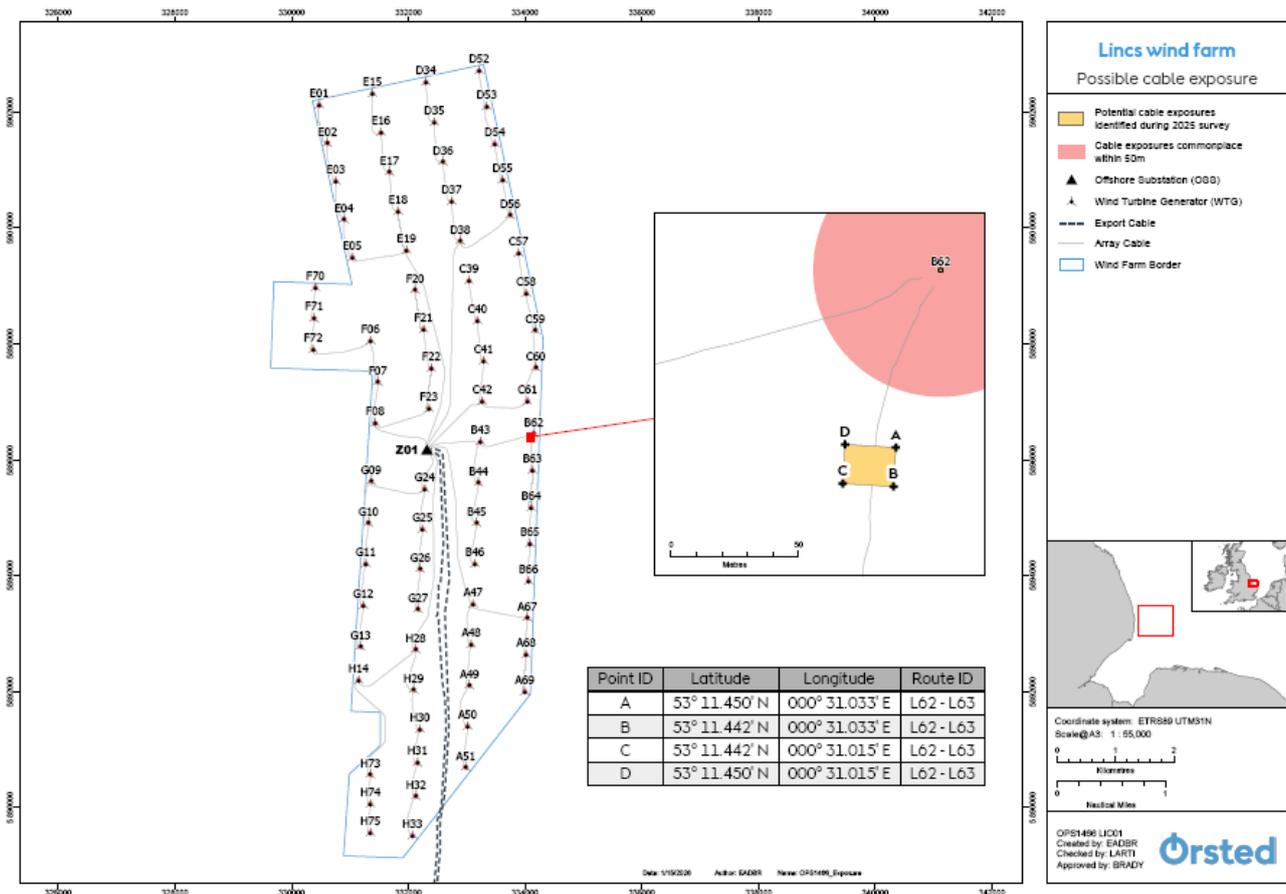
7.3 Cable exposure

As shown in the below chart, a survey undertaken in [July 2025] identified potential cable exposures at several locations beyond the commonplace exposures within the 50m radius around wind turbine and offshore substation foundations. The position and extent of the cable exposures shown in the below chart is limited to the burial status observed at the time of the survey. Cable burial status evolves over time, often rapidly. Mariners should not assume otherwise. Cable burial status is monitored periodically, and further information will be provided following future survey campaigns. Ørsted advises mariners to maintain care when operating within windfarm array areas.

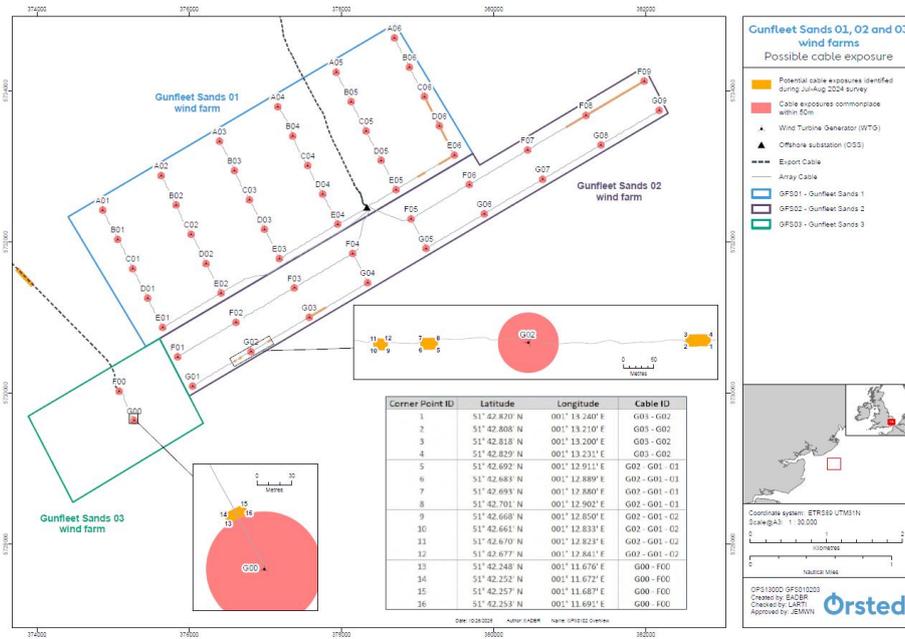
8.3 Cable Exposure

As shown in the below chart, a survey undertaken in [July-August 2024] identified potential cable exposures at several locations beyond the commonplace exposures within 50m radius around wind turbine and offshore substation foundations. The position and extent of the cable exposures shown in the below chart is limited to the burial status observed at the time of the survey. Cable burial status evolves over time, often rapidly. Mariners should not assume otherwise. Cable burial status is monitored periodically, and further information will be provided following future survey campaigns. Orsted advises mariners to maintain care when operating within our windfarm array areas.

As a result of a sedimentary surface and above average flow velocities, bathymetry within the Gunfleet Sands array area is constantly evolving.
