Natural England

# Cromer Shoal Chalk Beds MCZ Imagery Analysis

Final Report

Seastar Survey Ltd. Project Number – J/21/553

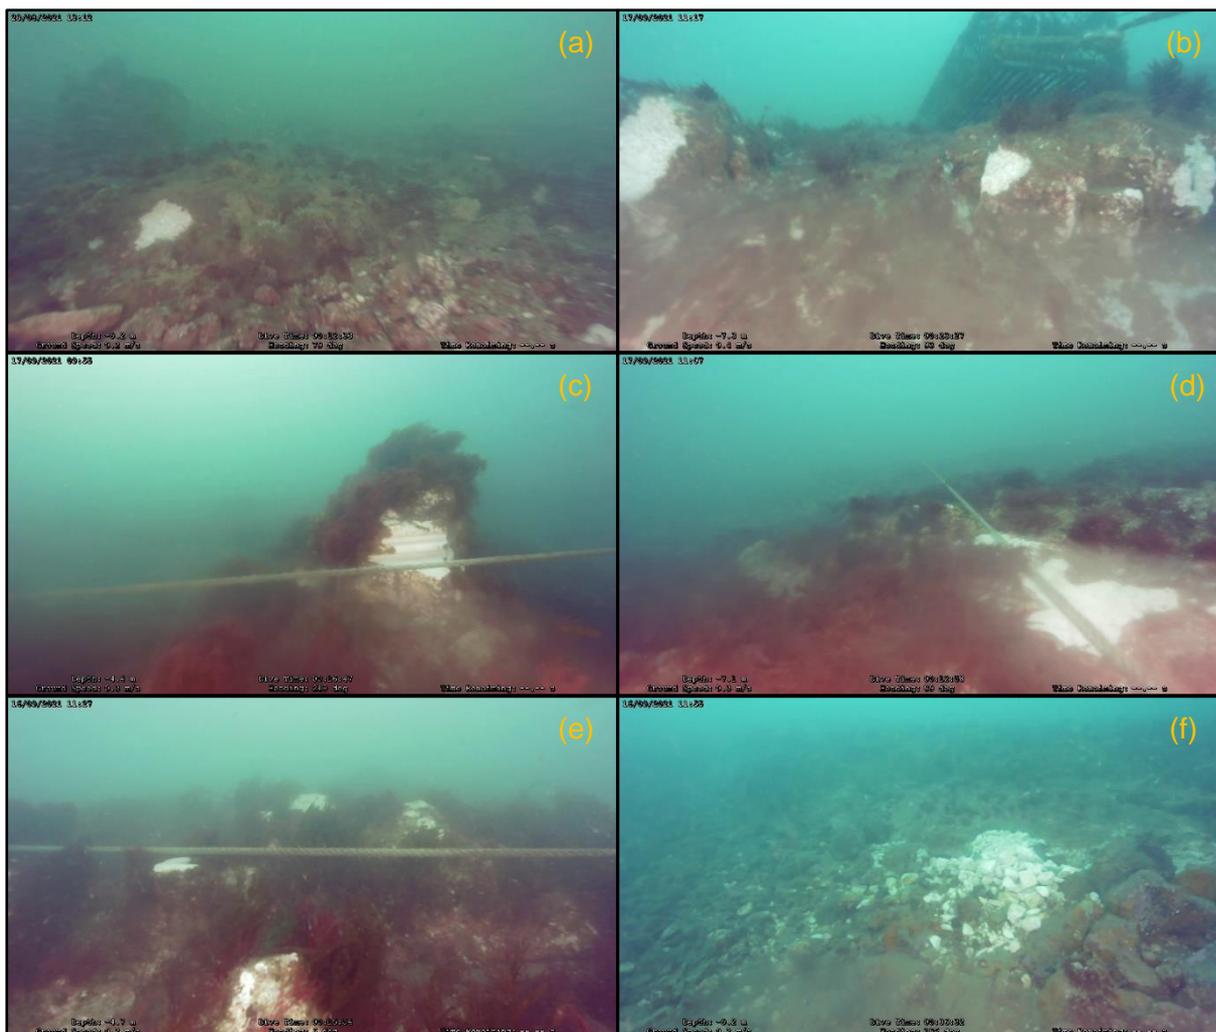
The most common form of chalk impact observed was grating (also recorded as 'grates' where assessment was difficult or uncertain). For the most part, these were small patches (recorded as head to arm size) where epibiota and the surface level of chalk had been removed from the vertical face of a rugged chalk outcrop (Figure 3.9a). Rarely was chalk debris observed below the impact site, however it was common to observe multiple bare chalk patches of a similar size in a small area on the same rock face (Figure 3.9b). The cause of impact was not generally apparent, though on occasion pots were observed in the vicinity of the impacts or elsewhere on the tow.

Cuts (Figure 3.9c) were recorded 11 times during the analysis. In all cases, rope associated with fishing gear was present in-situ. In some cases, multiple impacts caused by the same rope were observed in the same frame. A single burn impact, also with rope present in-situ, was observed on dive 83 (Figure 3.9d), and one instance of level shear of a small area of rugged chalk, likely caused by a rope present in the nearby vicinity, was recorded on dive 71 (Figure 3.9e).

Angular rubble (also recorded as the broad impact category 'rubble') was occasionally observed in the survey area, being recorded on two tows (dives 72 and 75). These instances were relatively clear examples of chalk impact, being present as fairly large (torso sized) rubble 'heaps' (Figure 3.9f), however, where angular chalk cobbles were observed in isolation, or where video quality prevented a reasonable assessment of cobble shape, chalk impacts were not recorded.

**Figure 3.9:** Examples of types of chalk impacts identified as part of the analysis of ROV video footage collected by EIFCA from CSCB MCZ in summer 2021: (a) single grating; (b) multiple grates on chalk outcrop with pot in situ; (c) cut on chalk stack; (d) burn; (e) level shear; (f) chalk rubble.
