Ørsted - East Coast Operational Assets

Notice to Mariners

Period of Notice: November 2025

Issue: 6

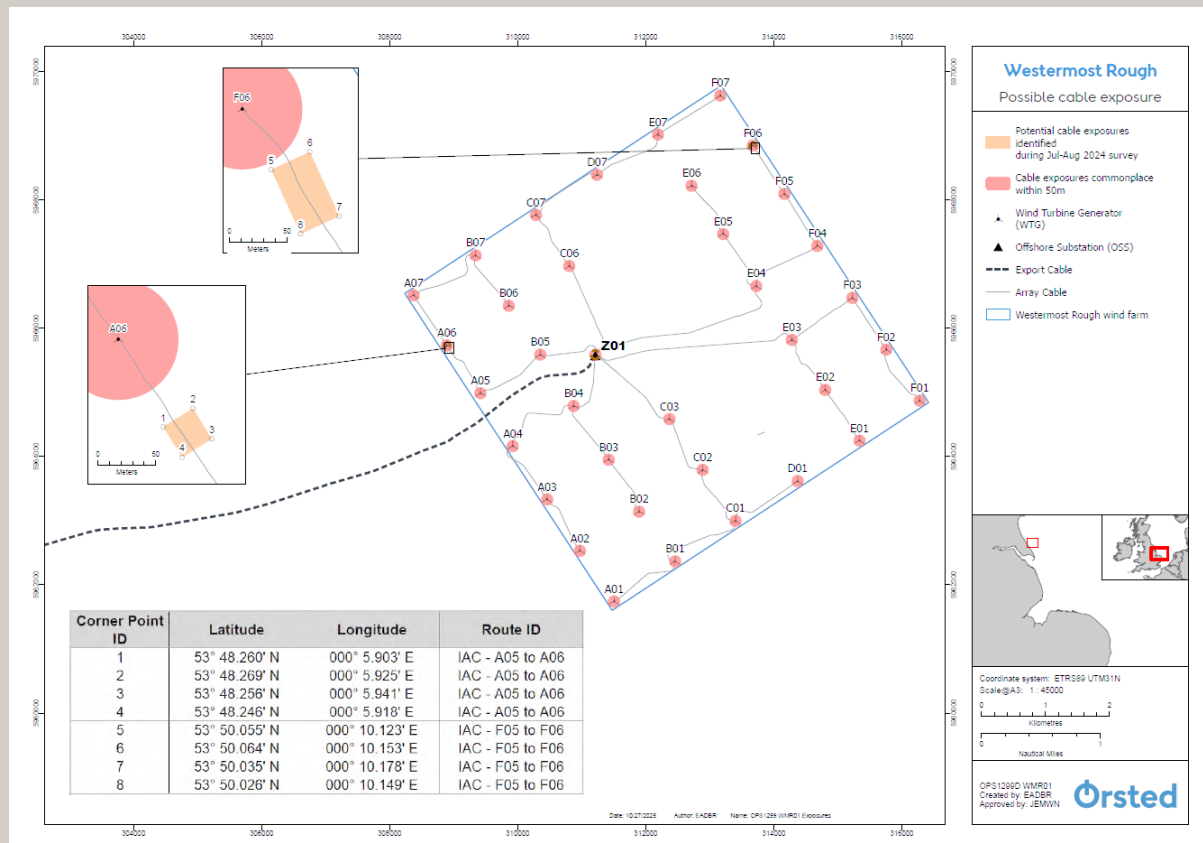
6.1 Cable Exposures

As shown in the below chart, a survey undertaken in [July-August 2024] identified potential cable exposures at several locations beyond the commonplace exposures within the 50m radius around wind turbine and offshore substation foundations. The position and extent of the cable exposures shown in the below chart is limited to the burial status observed at the time of the survey. Cable burial status evolves over time, often rapidly. Mariners should not assume otherwise. Cable burial status is monitored periodically, and further information will be provided following future survey campaigns. Ørsted advises mariners to maintain care when operating within windfarm array areas.

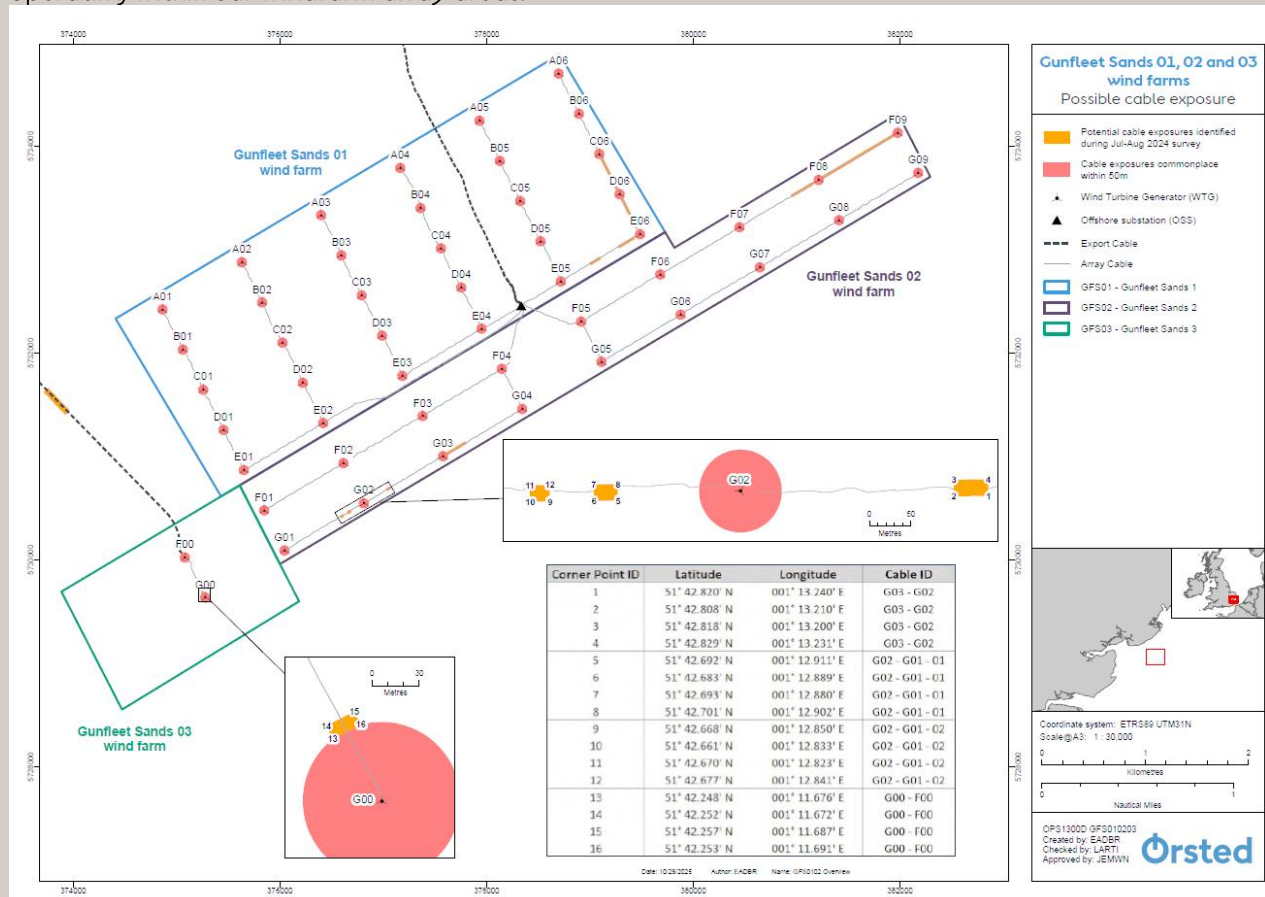
8.4 Cable exposure

As shown in the below chart, a survey undertaken in [July-August 2024] identified potential cable exposures at several locations beyond the commonplace exposures within 50m radius around wind turbine and offshore substation foundations. The position and extent of the cable exposures shown in the below chart is limited to the burial status observed at the time of the survey. Cable burial status evolves over time, often rapidly. Mariners should not assume otherwise. Cable burial status is monitored periodically, and further information will be provided following future survey campaigns. Orsted advises mariners to maintain care when operating within our windfarm array areas.

As a result of a sedimentary surface and above average flow velocities, bathymetry within the Gunfleet Sands array area is constantly evolving.
