Ørsted - East Coast Operational Assets

Notice to Mariners

Period of Notice: February 2026

Issue: 2

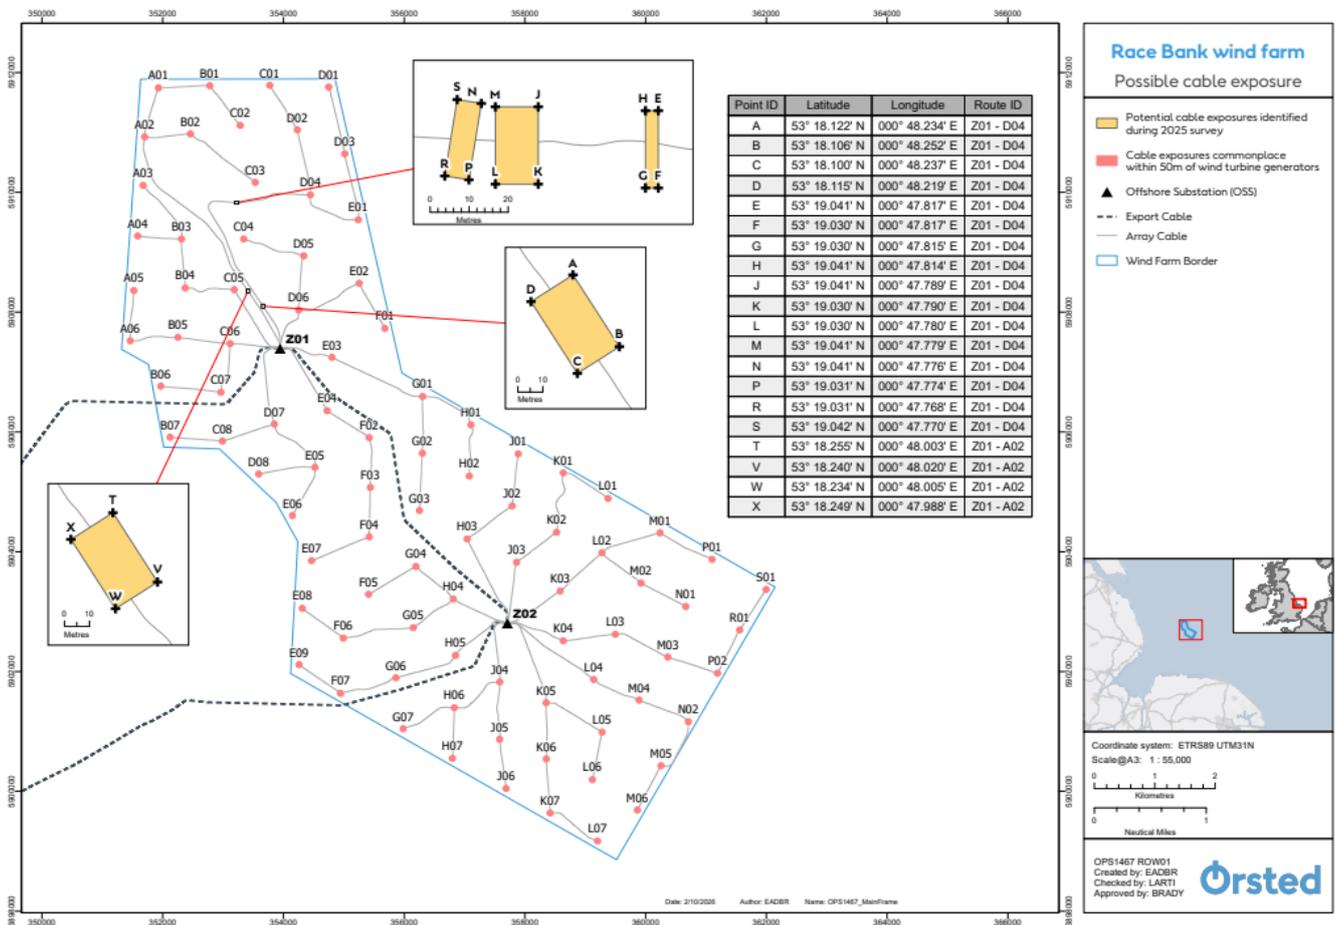
5.3 Cable exposure

As shown in the below chart, a survey undertaken in [July 2025] identified potential cable exposures at locations beyond the commonplace exposures within the 50m radius around wind turbine and offshore substation foundations. The position and extent of the cable exposures shown in the below chart is limited to the burial status observed at the time of the survey. Cable burial status evolves over time, often rapidly. Mariners should not assume otherwise. Cable burial status is monitored periodically, and further information will be provided following future survey campaigns. Ørsted advises mariners to maintain care when operating within windfarm array areas.

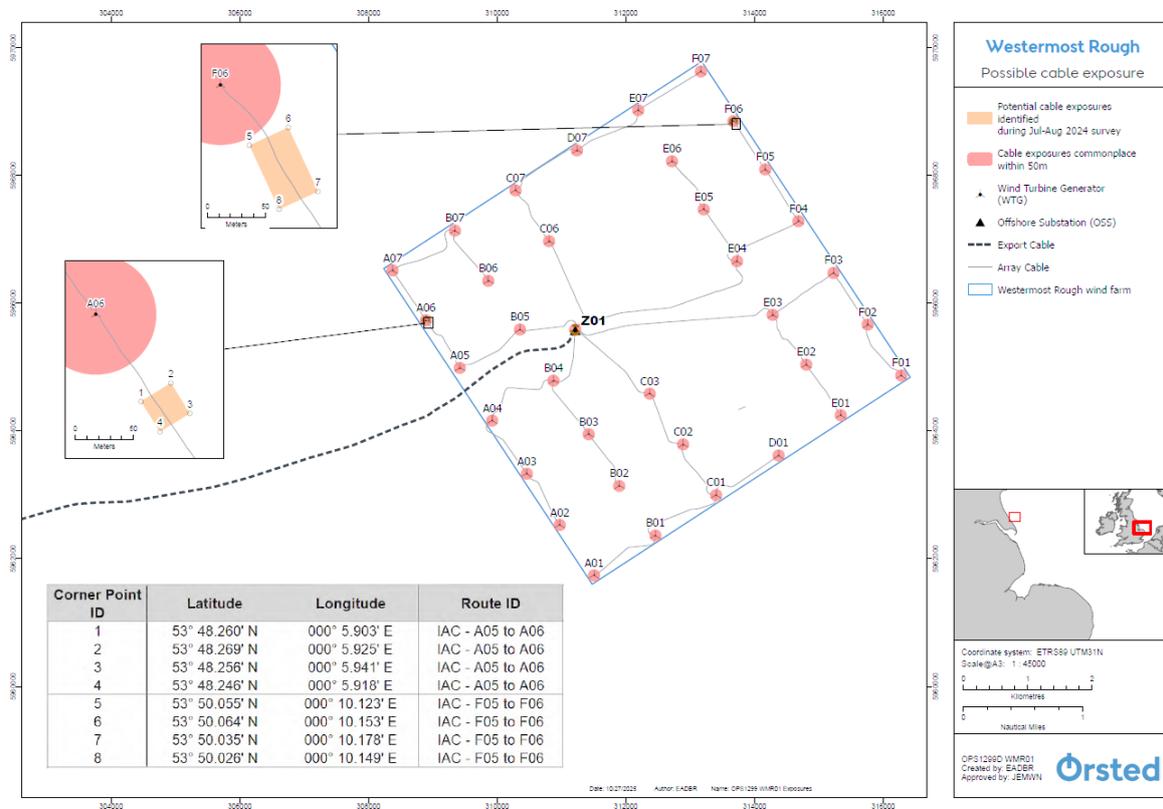
6.3 Cable Exposures

As shown in the below chart, a survey undertaken in [July-August 2024] identified potential cable exposures at locations beyond the commonplace exposures within the 50m radius around wind turbine and offshore substation foundations. The position and extent of the cable exposures shown in the below chart is limited to the burial status observed at the time of the survey. Cable burial status evolves over time, often rapidly. Mariners should not assume otherwise. Cable burial status is monitored periodically, and further information will be provided following future survey campaigns. Ørsted advises mariners to maintain care when operating within windfarm array areas.

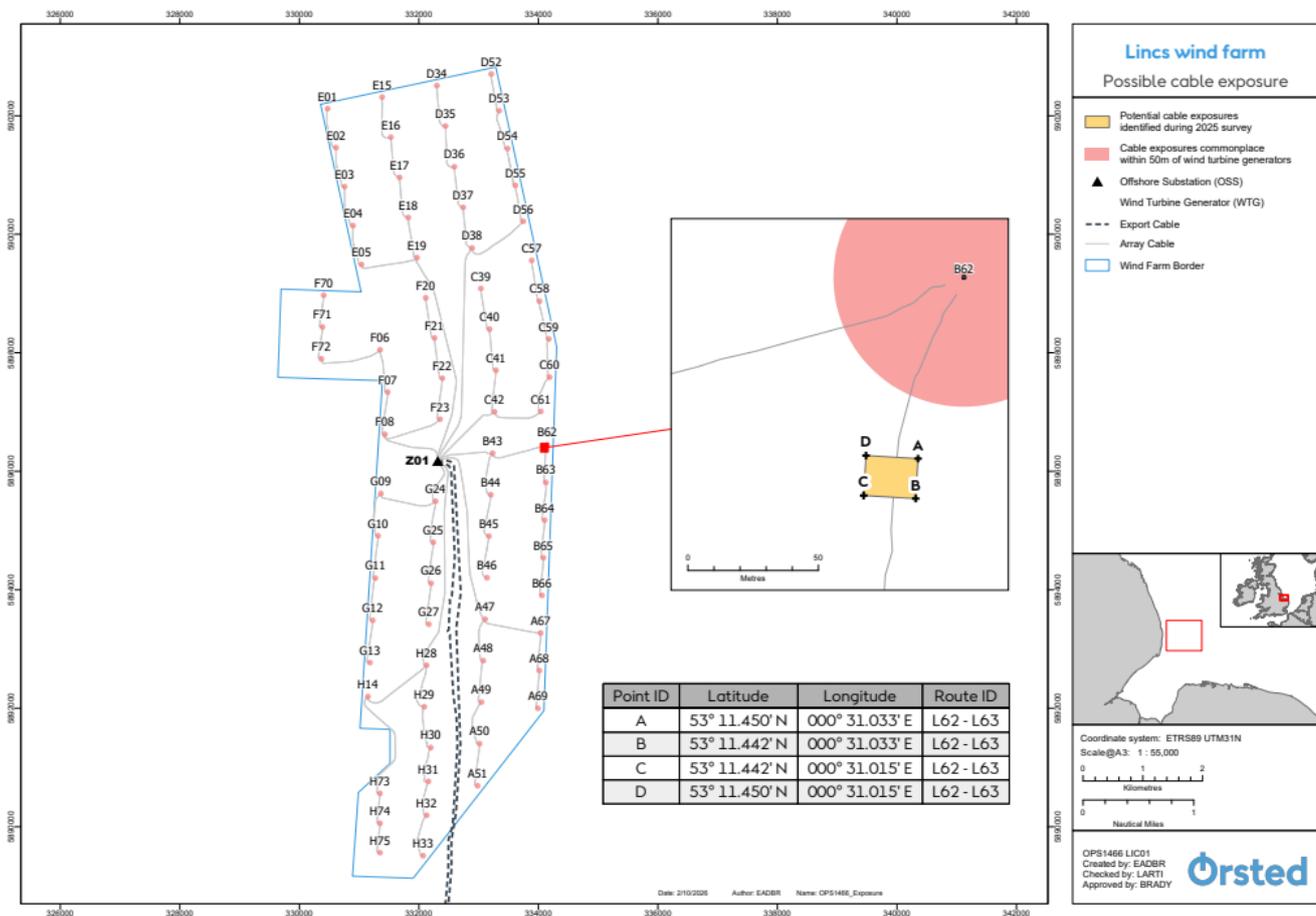
7.3 Cable exposure

As shown in the below chart, a survey undertaken in [July 2025] identified potential cable exposures at locations beyond the commonplace exposures within the 50m radius around wind turbine and offshore substation foundations. The position and extent of the cable exposures shown in the below chart is limited to the burial status observed at the time of the survey. Cable burial status evolves over time, often rapidly. Mariners should not assume otherwise. Cable burial status is monitored periodically, and further information will be provided following future survey campaigns. Ørsted advises mariners to maintain care when operating within windfarm array areas.

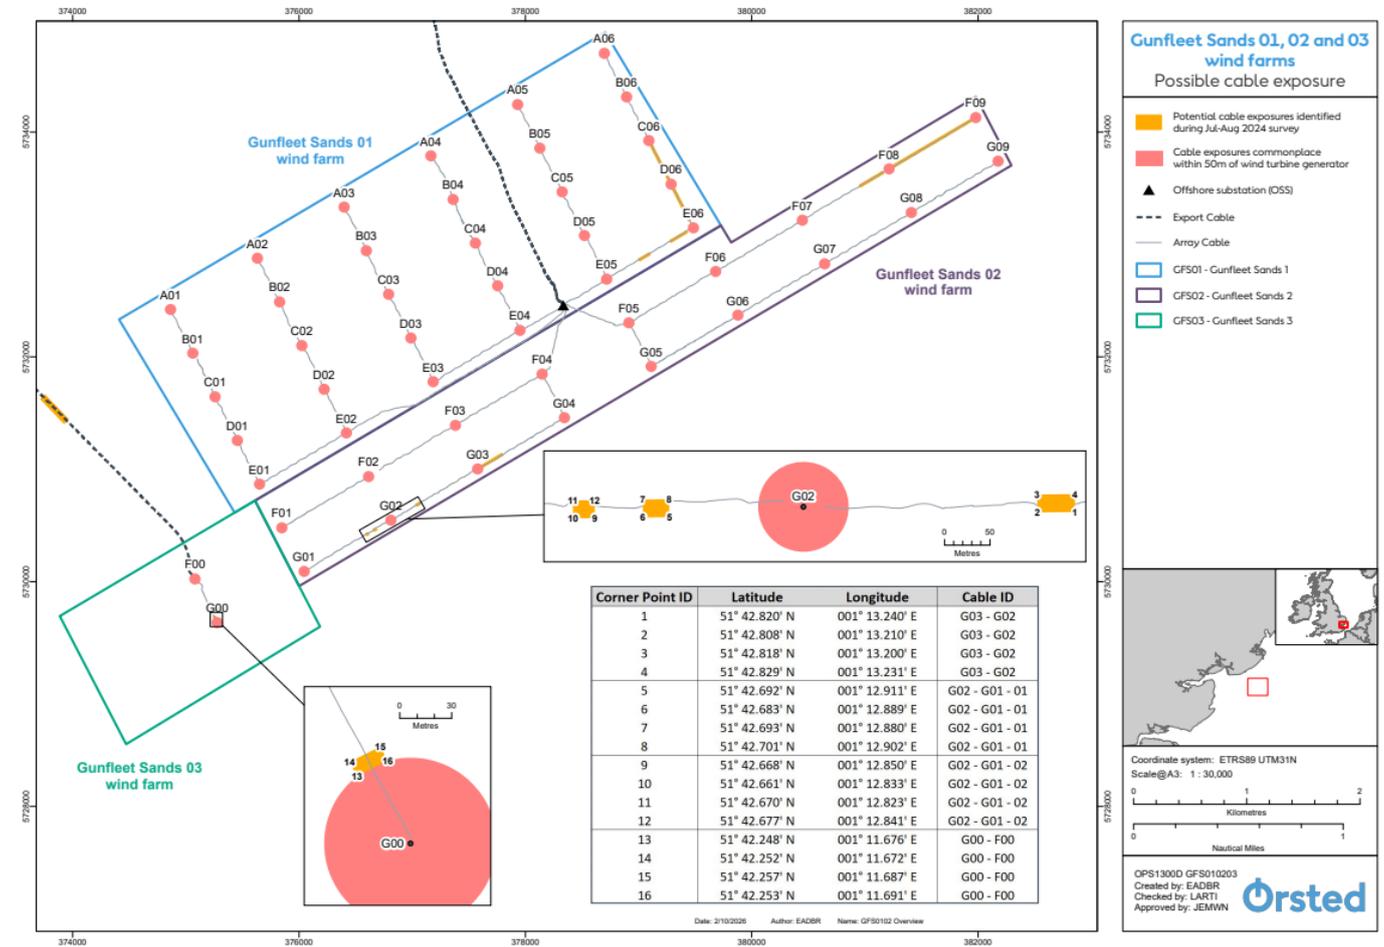
8.3 Cable Exposure

As shown in the below chart, a survey undertaken in [July-August 2024] identified potential cable exposures at locations beyond the commonplace exposures within 50m radius around wind turbine and offshore substation foundations. The position and extent of the cable exposures shown in the below chart is limited to the burial status observed at the time of the survey. Cable burial status evolves over time, often rapidly. Mariners should not assume otherwise. Cable burial status is monitored periodically, and further information will be provided following future survey campaigns. Orsted advises mariners to maintain care when operating within our windfarm array areas.

As a result of a sedimentary surface and above average flow velocities, bathymetry within the Gunfleet Sands array area is constantly evolving.
