# NOTICE TO MARINERS

## DOGGER BANK OFFSHORE WIND FARM

DATE OF ISSUE:	11/11/2023
NOTICE TO MARINER NUMBER	LF500013-MIP-DOG-NOT-0026 Rev 0002

### HAZARD - Dogger Bank A OWF Monopiles Unlit

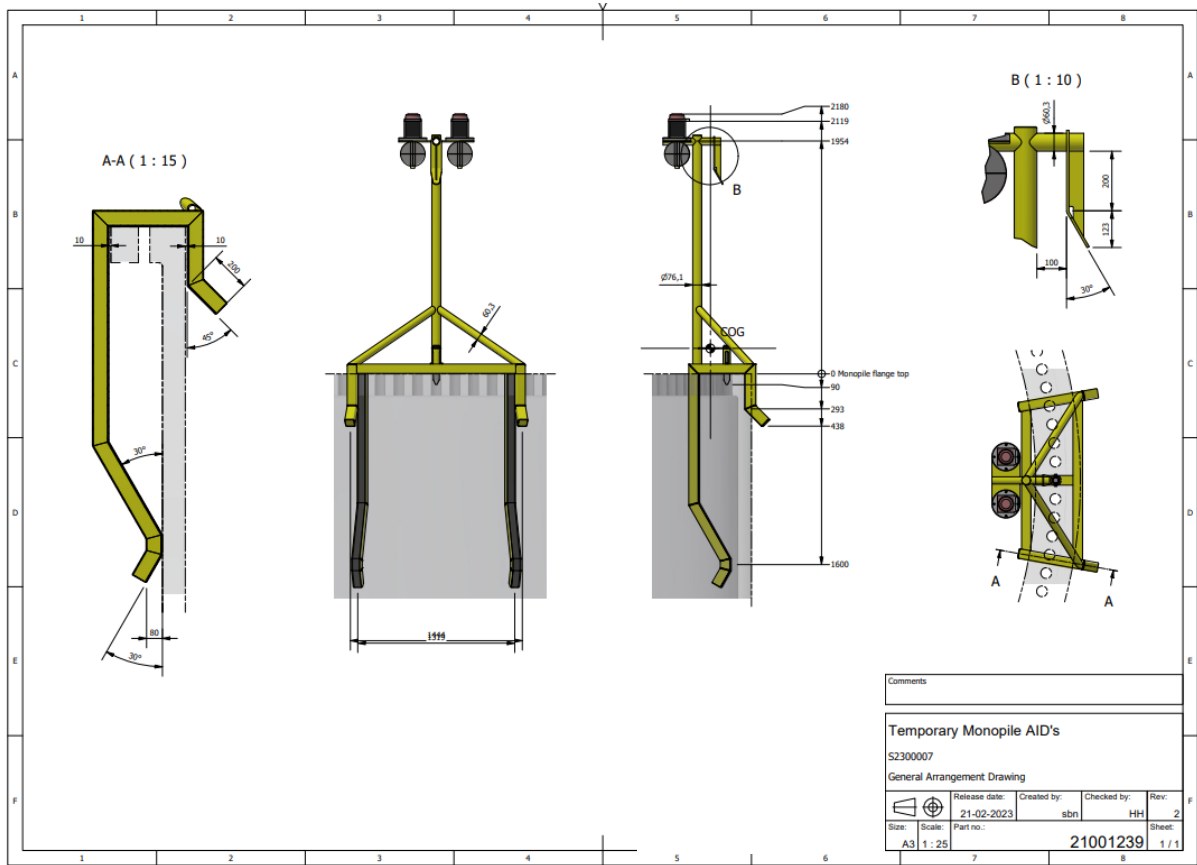
**Figure 2: Monopile Aid to Navigation Marking**

During Storm Babet, the temporary navigation lights on all 38 of the MPs were damaged and the lights are inoperative. Table 2 below provides coordinates of the monopile locations where temporary nav aids are missing or damaged. Figure 3 shows a monopile without a TP installed and with a temporary nav aid in place.

UPDATE: 36 monopiles remain unlit and unmarked, as detailed in Table 2 below.

A programme to repair and replace the temporary navigation lights is being undertaken. Once all are restored an update will be published and this NtM will be withdrawn.
